Appendix 6.6

Initial Borrow Pit Assessment

Carrick Windfarm Extension Project Team

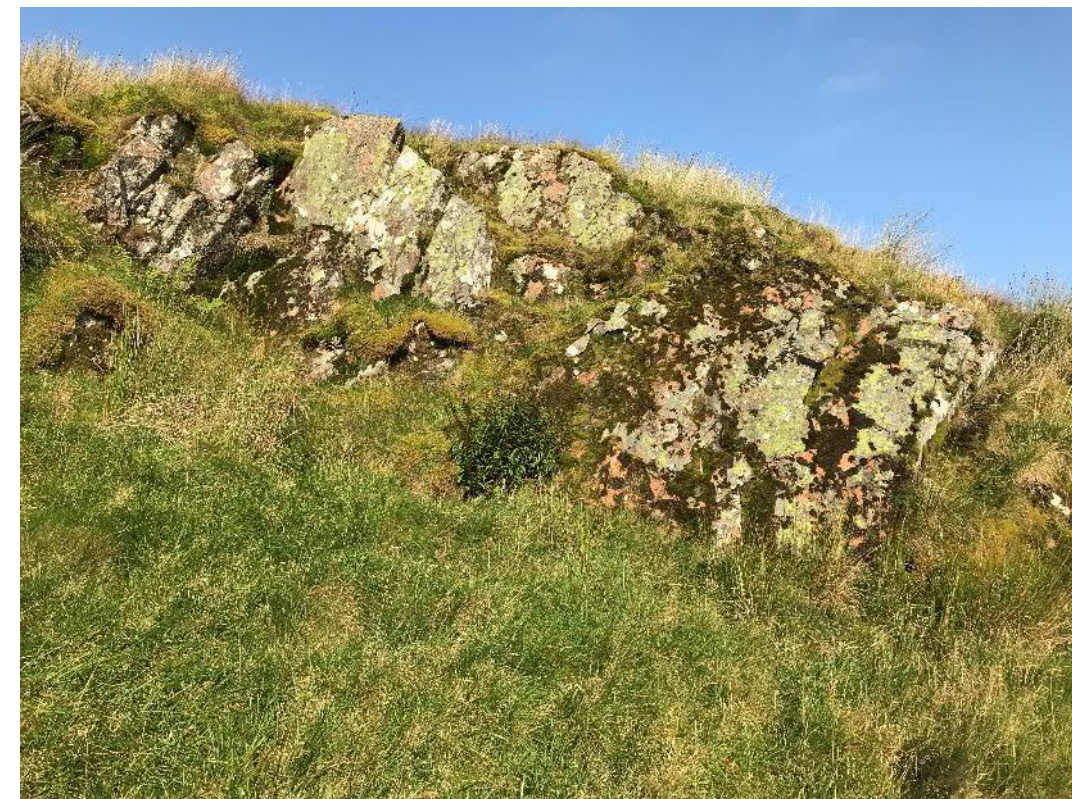
26. Borrow pit search area BP01 is located close to the route of the proposed access track for the Proposed Development. The slopes within BP01 range from low to moderate. Bedrock was not noted to outcrop directly in the area of BP01. One felsite outcrop was noted approximately 180m to the north west, however, given the distance from the proposed access track it was not deemed to be a suitable location. Geological mapping of the area of BP01 suggests there is the potential for two types of bedrock to be present.

Photograph 1 Rock outcrop approximately 180m north east of BP01 (facing north west, from NGR 237791, 598137).

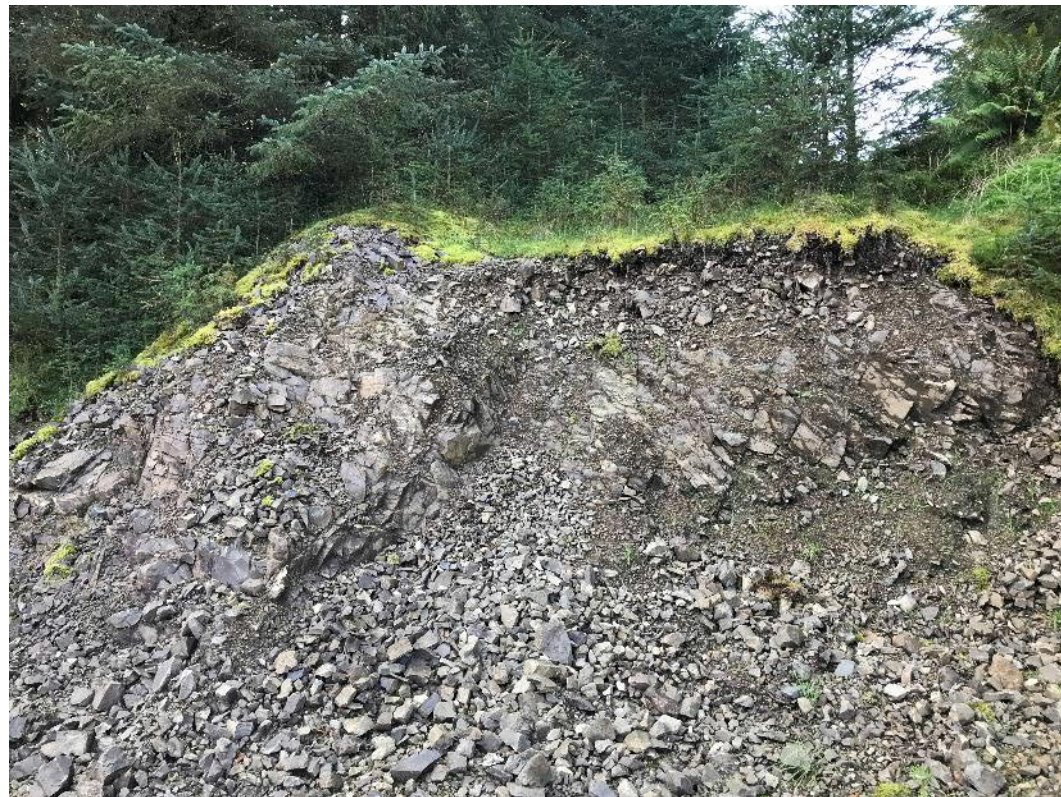
29. BP02 has been located to extend an existing previous borrow pit to the south and west, approximately 60m south of wind turbine 8. The area is currently afforested, with gentle to moderate slopes. This borrow pit search area is positioned off an existing forestry track.
30. Bedrock is clearly exposed in the quarry. The lithology is:
 - pinkish grey;

Photograph 2. Cut face at the area of BP02 (facing southwest, from NGR 237124, 598479)

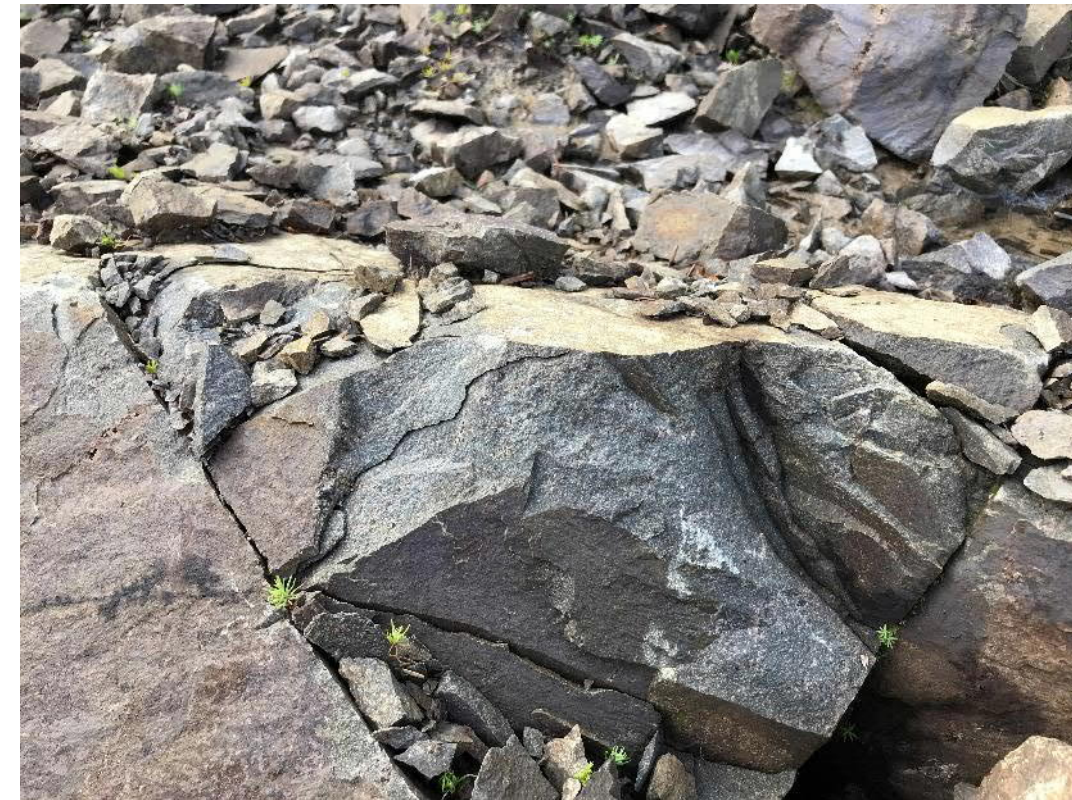
31. **Photograph 3** shows a closer view of the existing borrow pit face; a lot of weathered, broken and fine material is evident.
32. Probing indicated soft deposits (peat) depths ranging from 0.10m to 0.84m, with an isolated peat depth of 2.62m at the eastern extent, which is likely to be associated to banking of the existing forestry track. Slope angles range from 1 to 14 degrees. A break of slope is noted across BP02 running from south east to north west, however, no peat stability risks have been identified within or in the vicinity of BP02.

Photograph 3. Rock seen in the existing borrow pit at BP02

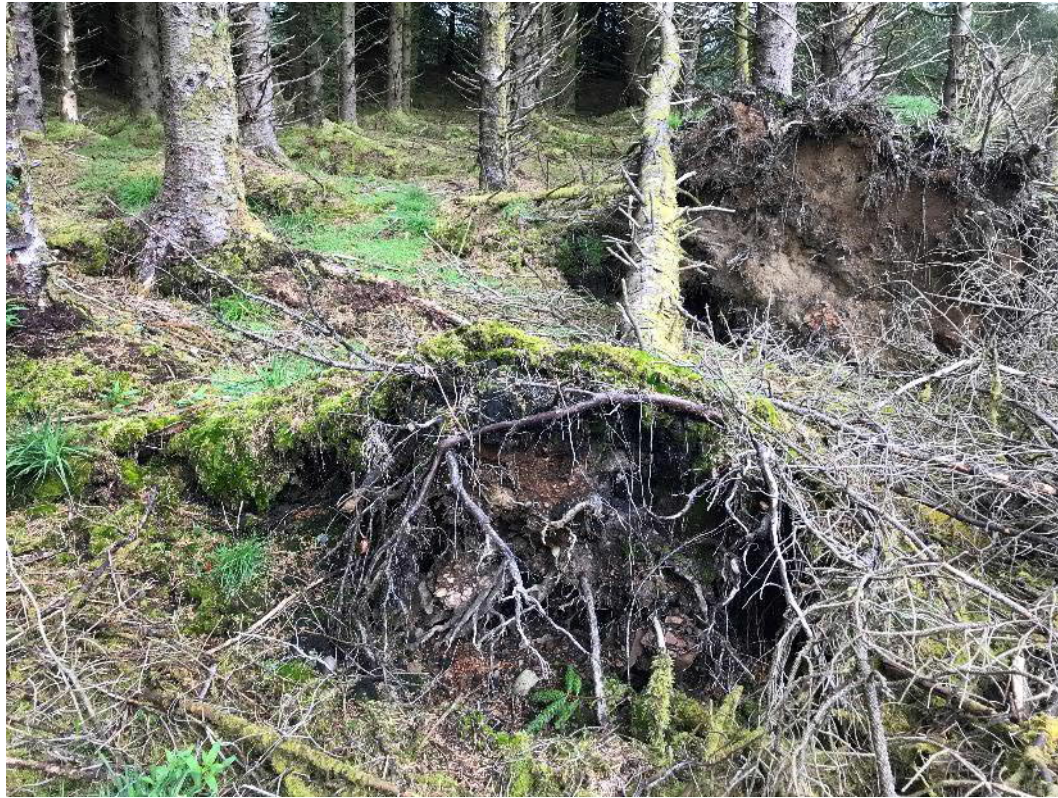
34. **Photograph 4** indicates that bedrock has been exposed following the overturning of a tree, indicating the presence of extremely shallow bedrock (<1m).

Photograph 4. Shallow bedrock can be seen in an area exposed by a fallen tree in the area of BP03 (taken at NGR 399362, 6124109)

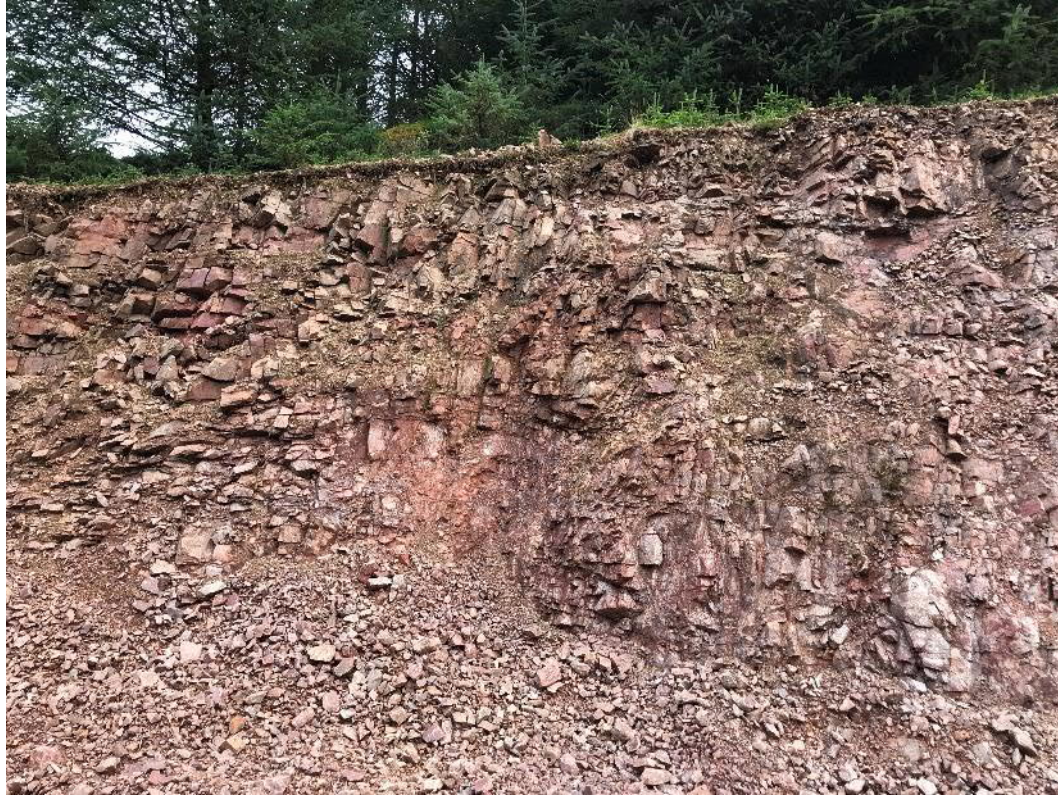
- intrusive igneous; and
 - felsitic.
36. **Photograph 5** shows a closer view of the existing borrow pit face; a lot of weathered, broken and fine material is evident.

Photograph 5. Cut wall in existing borrow pit at BP03 (facing south, from NGR 399386, 6124137)

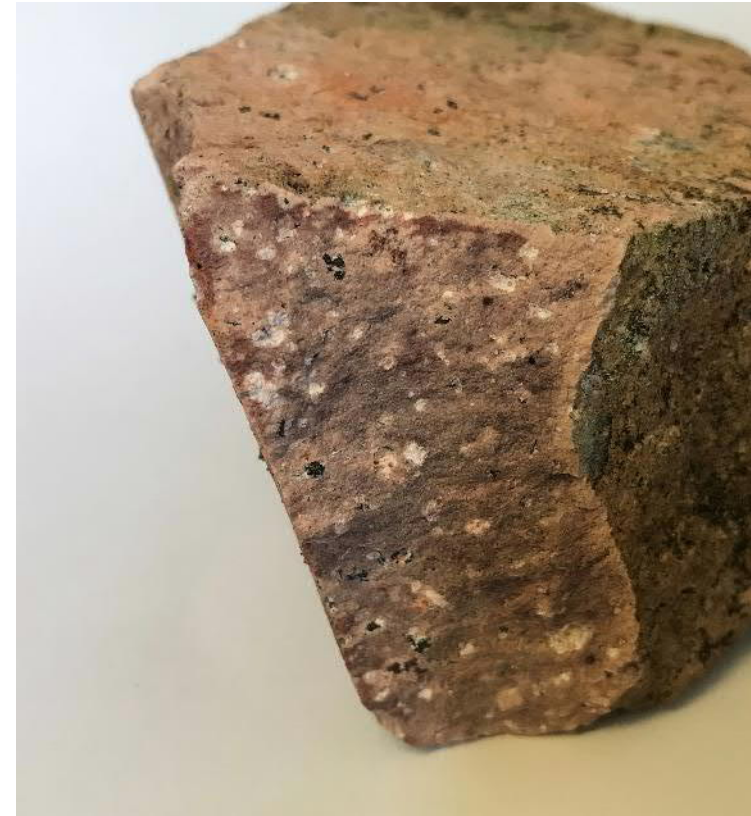
Photograph 6. Rock sample recovered from area of BP03

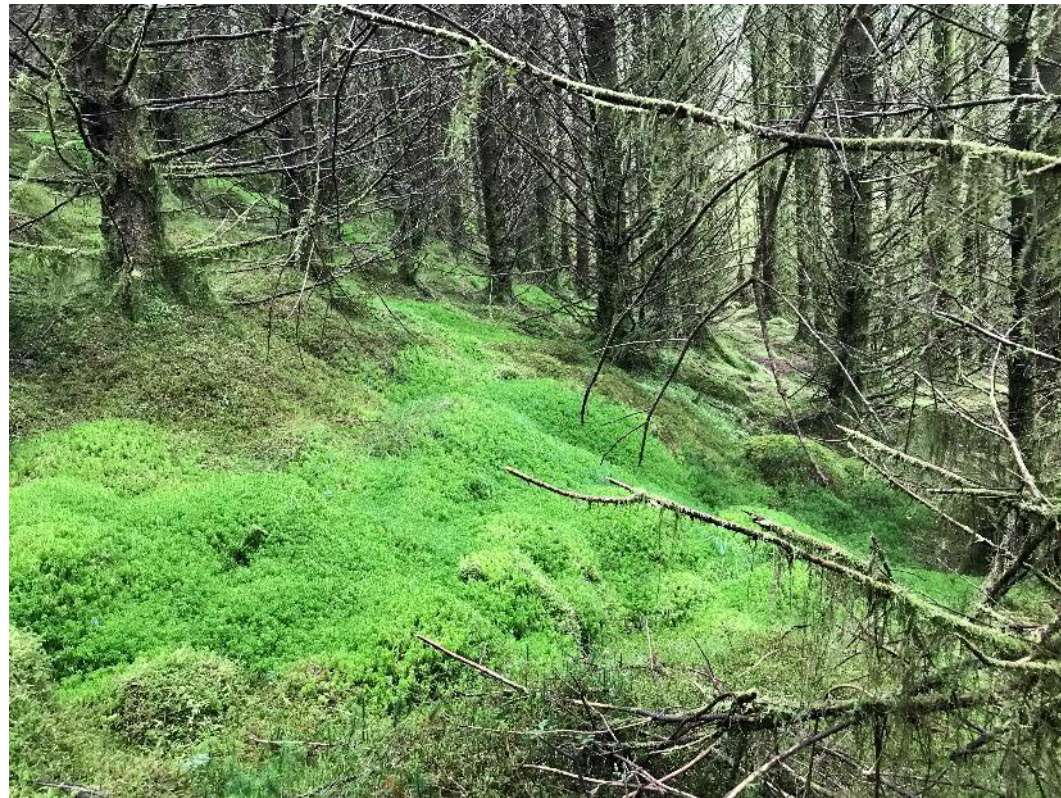
38. No rock outcrop was noted in the area of BP04; however, probes recorded depths to refusal less than 1m.
39. The proposed location consists of a tree and vegetation covered hillside (**Photograph 7**). Slopes are generally dipping approximately 30 degrees towards the access track (north east).

40. Numerous drainage channels are present between the rows of trees, indicating that surface run-off is potentially high in this area and could cause issues if this area was excavated for a borrow pit. A detailed drainage design would be undertaken and submitted to the Scottish Ministers, in consultation with the Scottish Environmental Protection Agency (SEPA), for approval prior to construction.

Photograph 7. Typical setting of BP04 (Facing northwest, from NGR 399386, 6124137)
