**HARESTANES WEST WINDFARM ENVIRONMENTAL
IMPACT ASSESSMENT**

TECHNICAL APPENDIX 8.6: BAT REPORT – TREE SURVEYS

Ae, Dumfries & Galloway

25.10.2024 VERSION 2

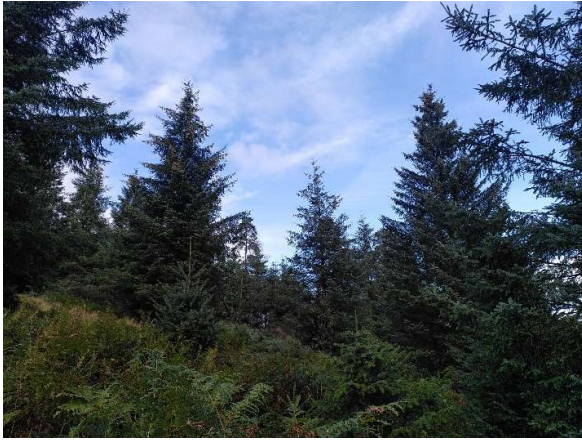
Photo 1: Areas of mature and semi-mature Sitka spruce with no roosting features present

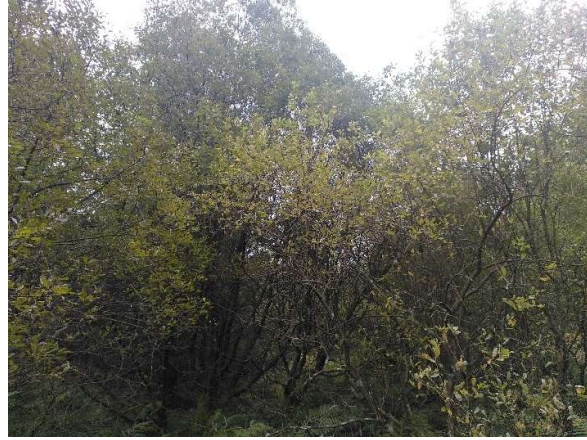
Photo 2: Areas of young scrub with minimal roosting features

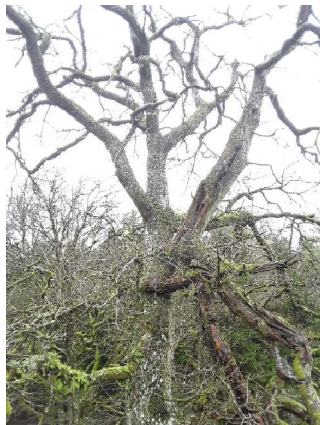
Photo 3: Tree TN 5 is standing dead wood with multiple potential features

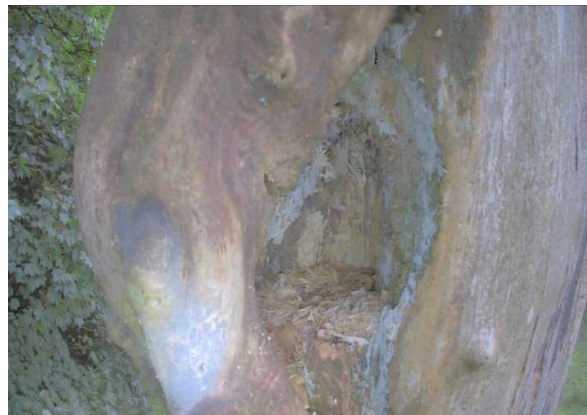
Photo 4: Tree TN 6 with an example of a rot hole within the dead monolith

Two trees, TN 6 -7, had features categorised as PRF-M. No evidence of bats was found within these features during either inspection. They are not considered likely to be suitable for a maternity roost due to the condition of the PRFs, but could hold multiple bats at any time of year.

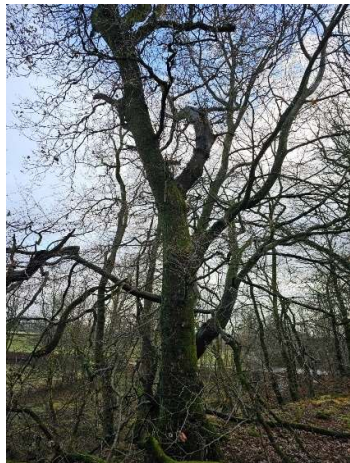
2	Large cavity in the northwest aspect from a tear out limb, relatively exposed. Over 20 metres from track upgrade route.	PRF-I

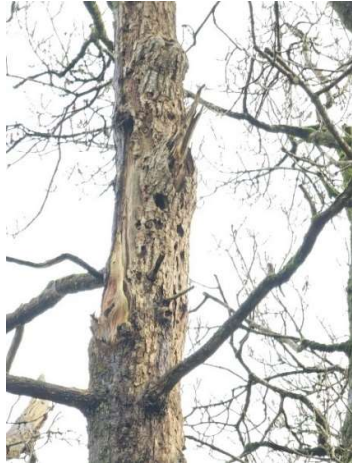
Target Note (tree tag #)	Grid Reference	Species	Feature	Description	Category	Photo
2	NY 04199 90339	Oak sp.	1	<p>Cavity from torn out branch at 6 metres. Dying tree. Likely damp cavity.</p> <p>Over 20 metres from track upgrade route.</p>	PRF-I

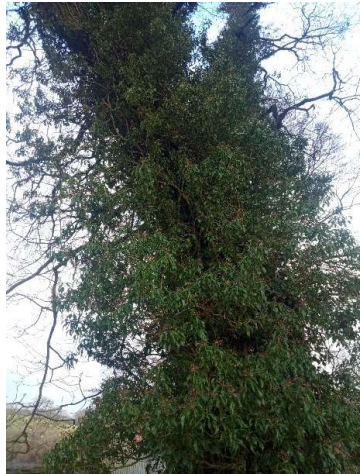
3	NY 04131 90343	Pendunculate oak	1	<p>Tree obscured by ivy.</p> <p>Aerial survey could not be arranged due to access. Some lower features investigated with telescopic camera.</p>	FAR

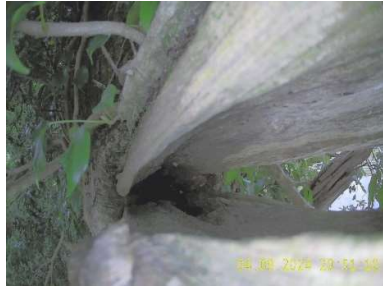
Target Note (tree tag #)	Grid Reference	Species	Feature	Description	Category	Photo
			2	Horizontal crack on eastern branch at 7 metres. Extends up the branch and inwards towards trunk but is open on both sides of the branch, except for a small area at the join to the trunk. Suitable for an individual bat.	PRF-I

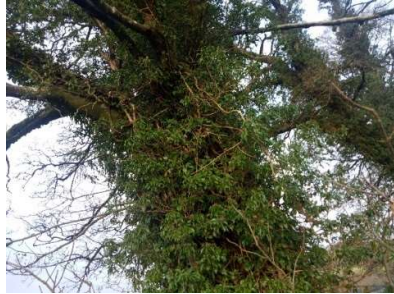
4	NY04126 90339	Sycamore	1	Tree obscured by ivy. Aerial survey could not be arranged due to access. Some lower features investigated with telescopic camera.	FAR

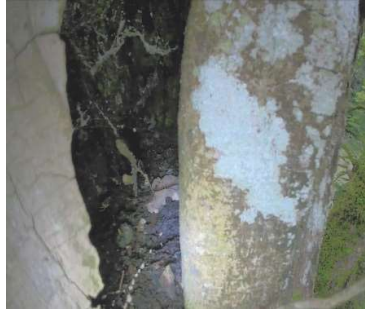
2	Large wound with rot and wound wood at 6 metres. Open and exposed. Only suitable for transient individual bats.	PRF-I

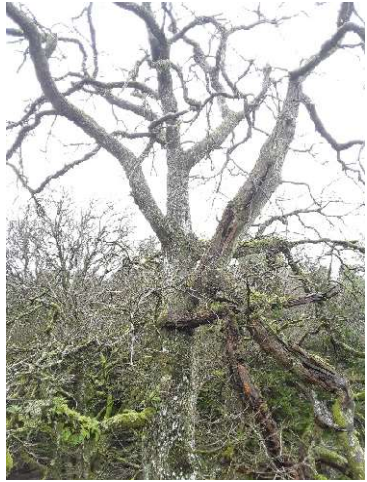
Target Note (tree tag #)	Grid Reference	Species	Feature	Description	Category	Photo
5	NY 03852 90691	Oak sp.	1	Large tear out wound in smaller stem.	PRF-I

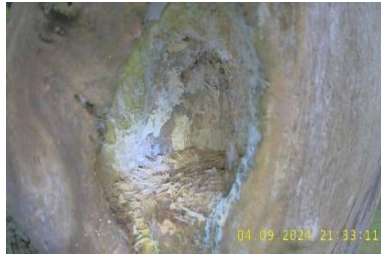
2	<p>Large split in branch which appears to extend into the limb. Could have potential for multiple bats.</p> <p>Over 20 m from track upgrade works.</p>	PFR-M	
6	NY 41018 70297	<p>Deadwood monolith – unknown species.</p> <p>Surveyed twice due to</p>	1	Woodpecker hole at 10 m, dry with domed apex, although tree overall dying and slightly damp. Potential for multiple bats, but not considered optimal for a maternity roost. No signs of bats (e.g. droppings) within the cavity.	PRF-M

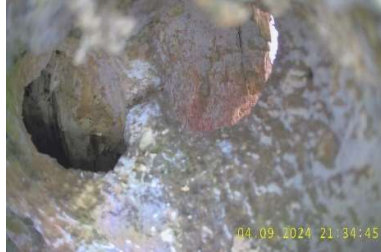
Target Note (tree tag #)	Grid Reference	Species	Feature	Description	Category	Photo
		PRF-M feature	2	Cavity at 11 m, extends sideways to other opening and downwards. Dry and deep cavity, although tree overall dying and damp. No signs of bats and not considered optimal for a maternity roost (the hole is relatively exposed with multiple entrances), although could house multiple bats.	PRF-M

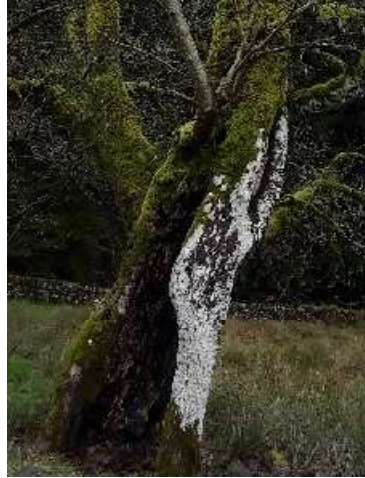
A close-up photograph of a tree trunk showing a large, irregular cavity with several openings. The wood is dark and appears damp. A timestamp '04.09.2024 21:34:45' is visible in the bottom right corner.
7	NY 03805 90674	Sycamore Surveyed twice due to PRF-M feature	1	Large wound with rot at base of tree running 1.5 m up the trunk. Extends further into trunk through small gaps in rotten wood. Wound wood may provide potential roosting features. Not considered suitable for maternity roosts as damp and rotten and decaying wood within the rot hole, but could have multiple bats (within different locations within the wound hole, rather than in one location within the wound hole).	PRF-M

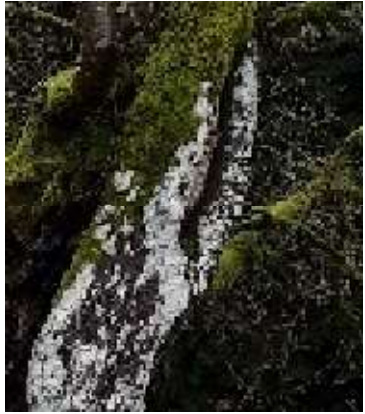
Target Note (tree tag #)	Grid Reference	Species	Feature	Description	Category	Photo
			2	Tear out wound at 1 m on east side. Connected to larger basal cavity. Wound wood may provide potential roosting features.	PRF-I

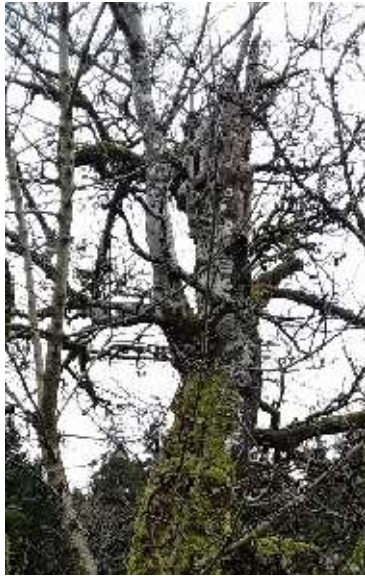
3	Snapped trunk at 10 m with large cavity within the trunk. Open and exposed but holes within rotting wood may provide potential roosting features for transient individual bats.	PRF-I

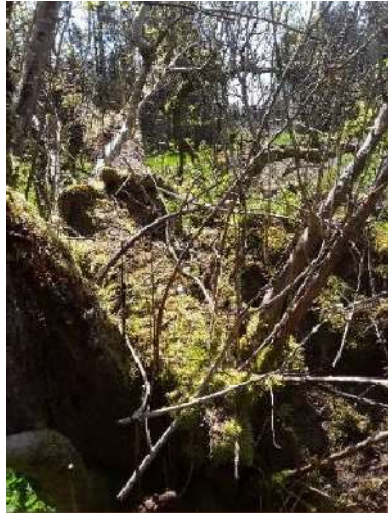
Target Note (tree tag #)	Grid Reference	Species	Feature	Description	Category	Photo
8	NX 96000 90261	Ash	1	Small areas of lifted bark.	PRF-I

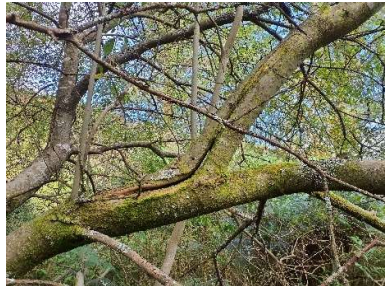
2	Fissures and gaps in the trunk due to collapse, mainly open and exposed.	PRF-I	
9 (478)	NX 96211 90206	Willow sp.	1	Horizontal crack on eastern branch at 2 m, 25 cm long and extending 5 cm up the inside of the branch. Crack goes through entire stem and is partially exposed.	PRF-I

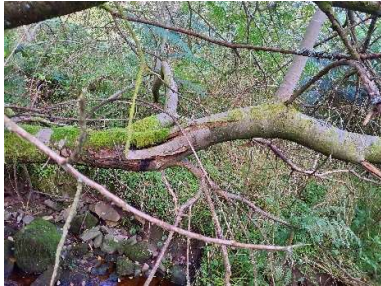
Target Note (tree tag #)	Grid Reference	Species	Feature	Description	Category	Photo
			2	Horizontal crack on eastern branch at 1 m high, 15 cm wide and extends up 10 cm inside the branch. Damp substrate and crack goes through the branch and is exposed.	PRF-I

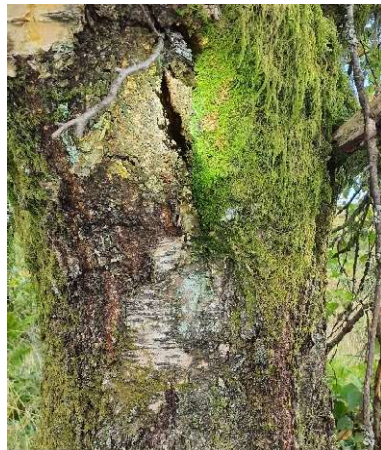
10 (486)	NX 96259 90197	Silver birch	1	Branch rip out wound at 80 cm high on south side of trunk with a cavity extending 15 cm deep and 15 cm up the trunk. Damp substrate but apex is dry and relatively sheltered.	PRF-I

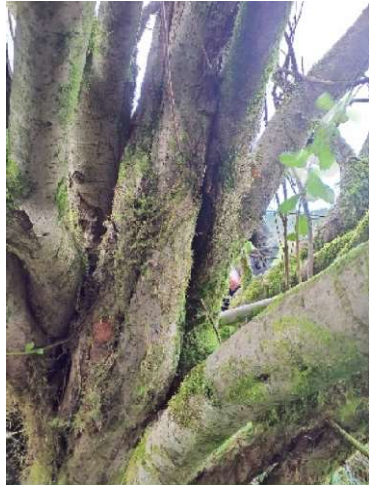
Target Note (tree tag #)	Grid Reference	Species	Feature	Description	Category	Photo
11 (489)	NX 96181 90222	Willow sp.	1	Fused stems at 50 cm high creating a dry cavity that extends 20 cm up, narrowing at apex.	PRF-I

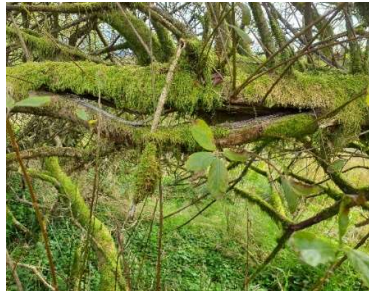
12 (467)	NX 96063 90151	Willow sp.	1	40 cm long horizontal crack through branch on north east side at 1 metre high. Cavity extends into the branch towards the trunk.	PRF-I

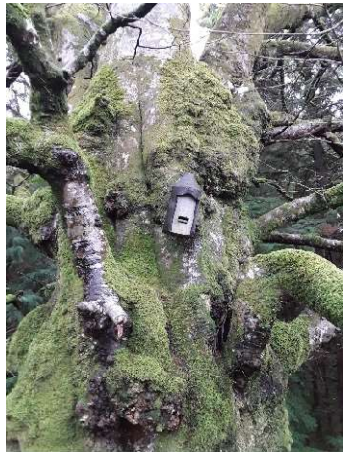
A bat box (TN 13) was noted at grid reference NY 03856 90708 and this contained a single bat dropping, likely pipistrelle species, so is confirmed as a bat roost. It is over 35 m from the track.

Target Note (tree tag #)	Grid Reference	Species	Feature	Description	Category	Photo
13	NY 03856 90708			Bat box: 1 Schwegler woodcrete bat box was inspected. No bats were found inside but a bat dropping was present indicating this box is used as a roost. The dropping is likely to be from a pipistrelle species.
