# Appendix 11.1 Peat Slide Risk Assessment

- 1.1 This Peat Slide Risk Assessment (PSRA) report provides an overview of peat slide mechanisms, desk study information relating to the site, and survey results to highlight any risk of peat slide within the Proposed Development area.

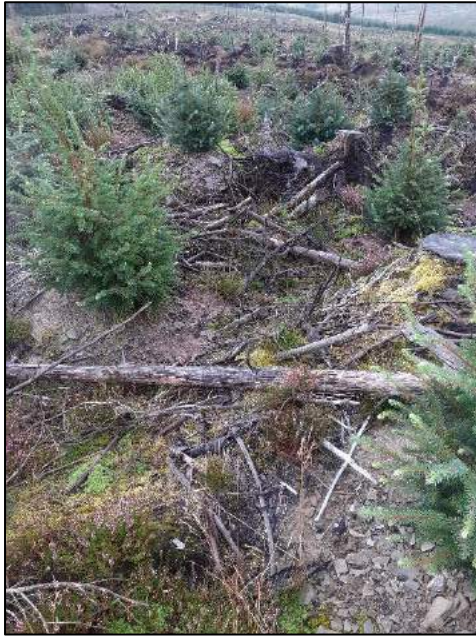
**Photograph 1 – Disturbed soils at T6 location**

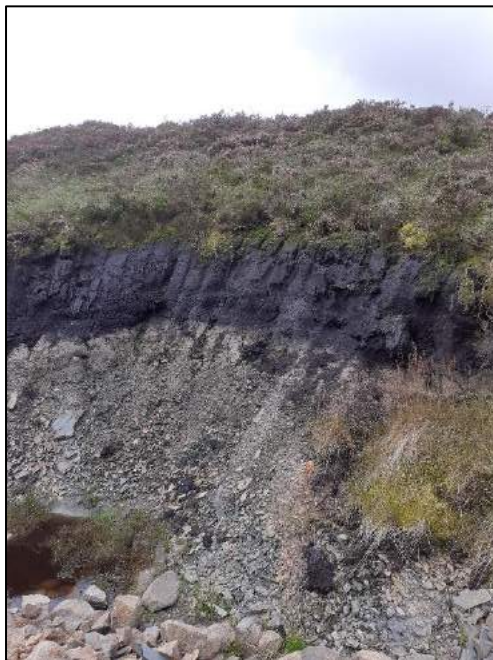
**Photograph 5 – Exposed peat over rock near T3**

- 4.19 Peat across most of the site was observed to be disturbed and modified by the presence of tree roots and, in some areas uprooted due to wind blow. Conifer needles blanketed much of the site area within the forestry, obscuring ground conditions. However, in some locations, exposed banks of watercourses exhibit granular till materials (see below). Near the proposed T3 location, an exposure adjacent to a watercourse exhibits peat overlying weathered sedimentary rock.

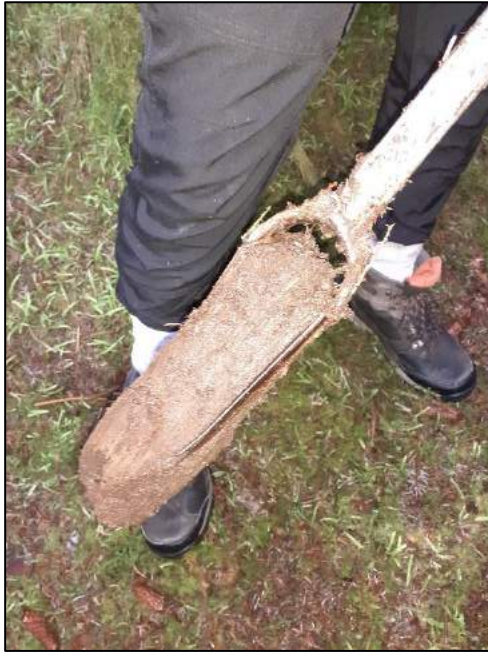
**Photograph 6– Auger from T2**

Location	Easting	Northing	Depth (m below ground)	Notes
Turbine 1	273972	632452	0.99	Dark brown, wet, somewhat fibrous in upper part only, possible acrotelm/catotelm boundary.  Fairly high carbon and moisture content.
Turbine 2	273971	633022	0.65	Pale brown, very low carbon and low moisture content, not peat.
Turbine 4	274485	632982	0.55	Medium brown, cohesive. Very low carbon and moisture content, not peat
Turbine 5	275207	633452	0.90	Pale brown, very low carbon and low moisture content, not peat.

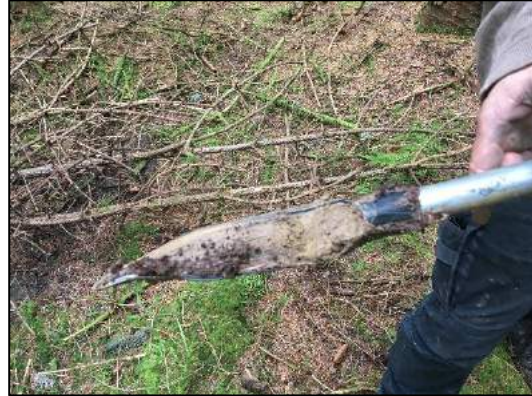
**Photograph 7 – Auger from T5**

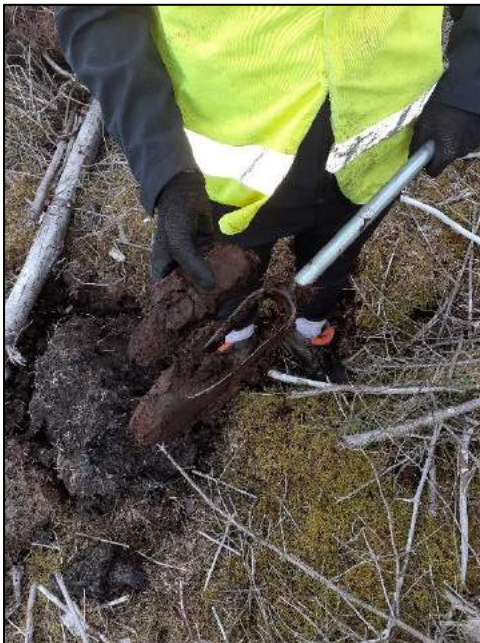
**Photograph 8 – Auger from T7**

Location	Easting	Northing	Depth (m below ground)	Notes
Turbine 7	273914	634053	1.00	Dark brown, not fibrous. Fairly high carbon and moisture content.
Turbine 9	274592	634184	0.85	Dark brown, somewhat fibrous. Fairly high carbon and moisture content.
Turbine 10	274504	634697	0.78	Medium brown, fibrous in upper part. Fairly high carbon and moisture content.
Turbine 13	275843	634840	0.50	Medium/dark brown, fibrous. Low carbon and low moisture content, peaty soil but not peat.
Turbine 15	275885	635450	0.80	Medium brown, fairly cohesive. Moderate carbon and moisture content, likely peaty soil but not peat.
Turbine 16	275615	635837	0.65	Medium brown, granular. Very low carbon and moisture content, not peat.
Turbine 17	276395	635346	0.55	Medium/dark brown, somewhat cohesive. Moderate carbon and moisture content, likely peaty soil but not peat.
Turbine 19	276280	636033	0.60	Medium/dark brown, not fibrous. Fairly high carbon and moisture content.

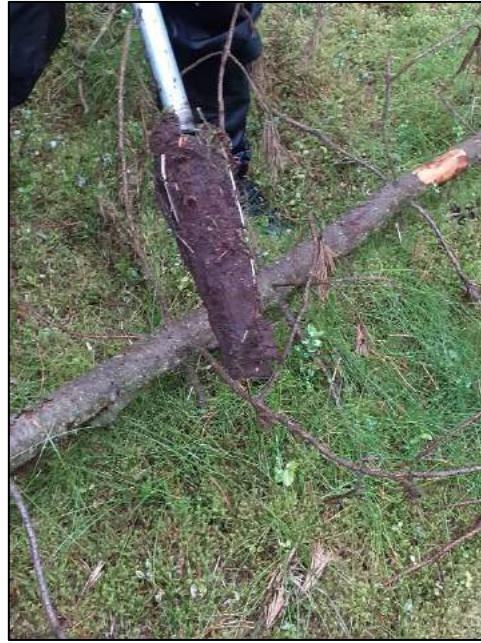
**Photograph 9 – Auger from T9**

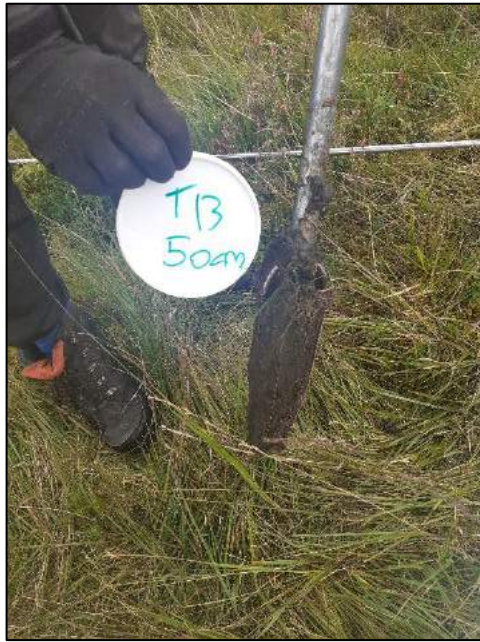
Photograph 10 – Auger from T13

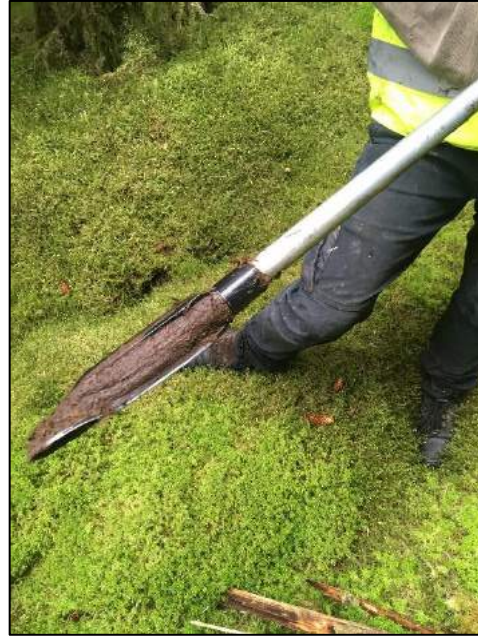
Photograph 11 – Auger from T19
