**Scottish Power Renewables**

# **Earraghail Renewable Energy Development: Peat Slide Risk Assessment**

Technical Appendix 10.1

**FEBRUARY 2022**

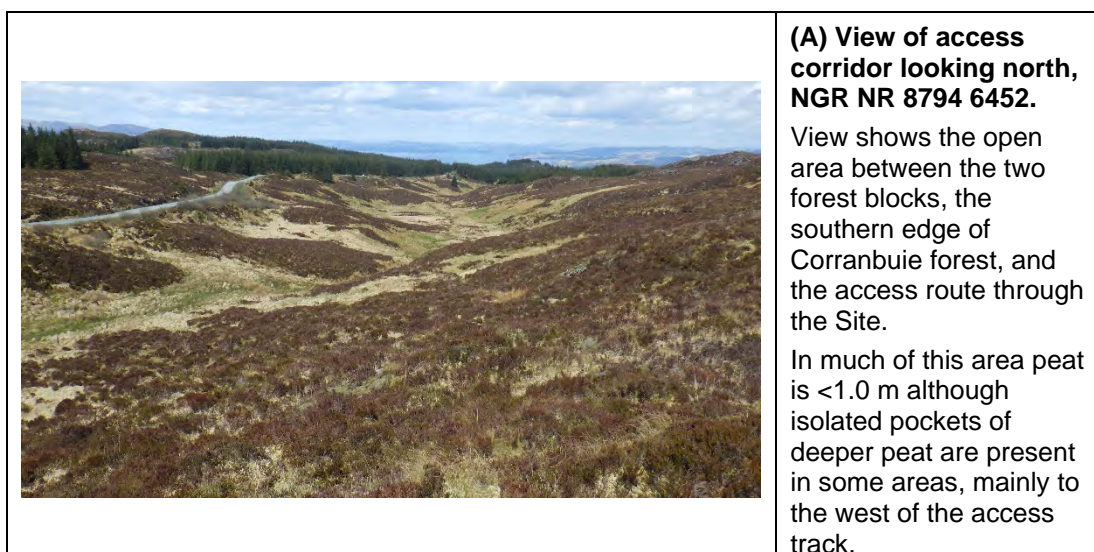
<p><b>(B) View across open area looking south-east, NGR NR 8787 6400.</b></p> <p>View shows a lochan near the summit of Cruach Doire Lèithe within the open section of the Site.</p> <p>Peat is of variable thickness across this area but is generally &lt;1.0 m. The grey areas behind the lochan are areas of exposed bedrock, where peat is absent.</p>
	<p><b>(C) View across open area looking west from access road, NGR NR 8777 6393.</b></p> <p>View shows central open area with the headwaters of the Allt Chapull-cloiche initially flowing west, then north to the right of the photo.</p> <p>Peat is variable in this area, mainly &lt;1.0 m. An area of deeper peat (&gt;2.0 m) is present to the south, just out of shot.</p>
	<p><b>(D) View of existing access track looking south, NGR NR 8776 6389.</b></p> <p>View shows the drainage ditch along the edge of the access road with a peat layer exposed at the top of the slope.</p> <p>Peat is of variable thickness across this area but is generally &lt;1.0 m apart from occasional pockets of deeper peat. In this photograph, peat soils are &lt;0.5 m thick.</p>

<p><b>(E) View across Site looking south, NGR NR 8980 6270.</b></p> <p>View south between Càrn Chaluim and Guallan Mhòr showing forested area to RHS, and recently harvested area to LHS. A tributary to the Skipness River is present within the small valley.</p> <p>Peat is generally &lt;1.0 m, with an area of deeper peat within the forestry to the RHS.</p>
	<p><b>(F) View of Site looking north-east, NGR NR 8829 6180.</b></p> <p>View shows example of Skipness forest with a tributary to the Garbh Allt flowing through the fire break. This area is representative of the open breaks within mature forestry.</p> <p>Peat is variable, with some areas &gt;2.0 m interspersed with shallower peat.</p>
	<p><b>(G) View across Site looking north, NGR NR 9070 6190.</b></p> <p>View shows a recently harvested area of Skipness forest with remaining stumps, brash and disturbed shallow soils.</p> <p>Peat is recorded either as absent (&lt;0.5 m) or shallow (&lt;1.0 m) throughout most of the harvested areas; however, soils are extensively disturbed from the harvesting activity with fragments of shallow bedrock brought to the surface.</p>

<p><b>(H) View north-west from NGR NR 8800 along forestry drain.</b></p> <p>Forestry drain within Skipness Forest showing significant Sphagnum growth within the ditch.</p> <p>Peat is variable within the forestry, with pockets of deep peat (&gt;2.0 m) in between areas of shallow (&lt;1.0 m) or no peat (&lt;0.5 m). Areas of peat development are mainly in areas with flat or gentle slopes.</p>
 	<p><b>(I) View of Site looking west, NGR NR 8740 6280.</b></p> <p>Remnants of former small quarry within north-eastern part of Skipness forest showing thin layer of peat above shallow bedrock.</p> <p>Peat depths in the area are variable with shallow/no peat common in areas like this with significant ground slopes.</p>
 	<p><b>(J) View across Site looking north-west along drainage ditch, NGR NR 8980 6200.</b></p> <p>View shows recently harvested area including disturbed shallow soils with mixed loose bedrock.</p> <p>Peat is almost exclusively recorded at depths &lt;1 m in the area. Soils and peat in harvested areas like this have been significantly disrupted by harvesting activity, resulting in mixing of soil layers and incorporation of broken fragments of bedrock within the soil layers.</p>

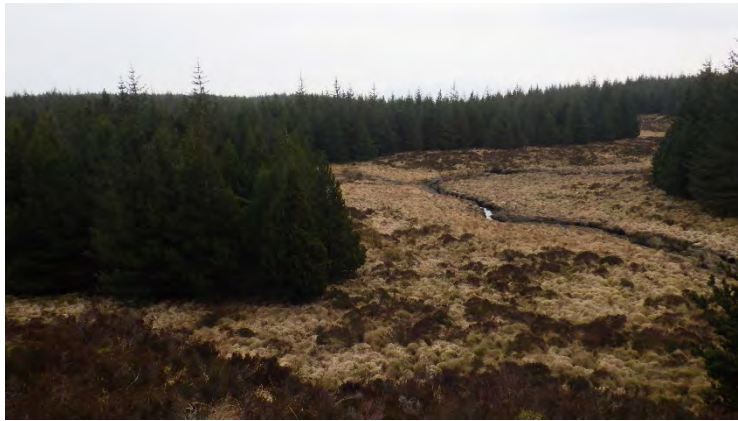
**(K) View south from  
NGR NR 8775 6300  
along watercourse**

View shows a fire break with a tributary to the Garbh Allt from near the northern edge of Skipness forest looking south towards T07.

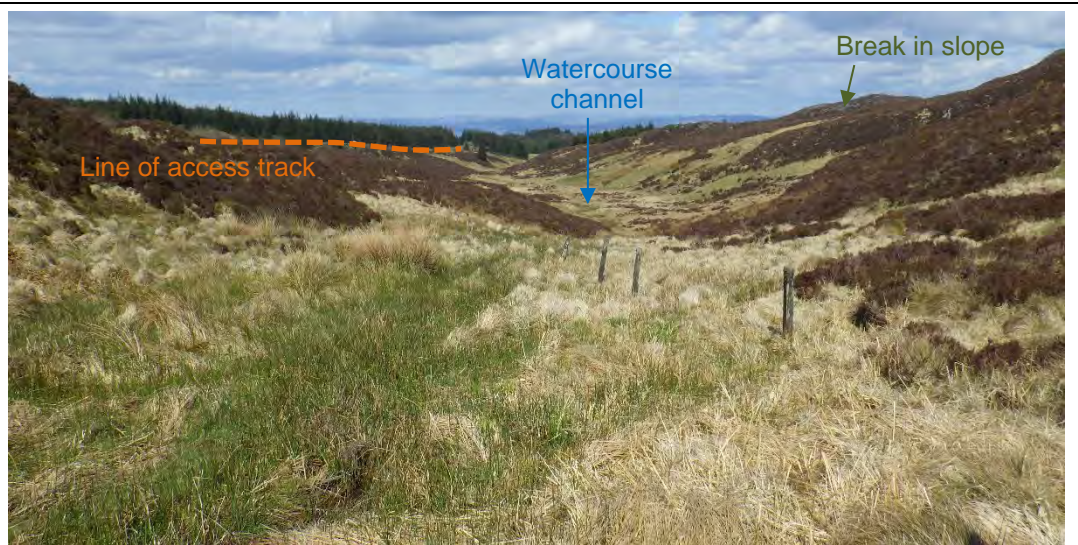
Photograph looking N along watercourse near Area 1

Rocky outcrops are visible along the slope to the east side of the watercourse, making it unlikely that there is much peat development along the slope. Peat depth records from similar slopes in the nearby area are consistently <1.0 m, and often <0.5 m, with a very patchy distribution indicating highly variable peat development. There is likely to be peat within the watercourse channel, where the slope angle is very low.

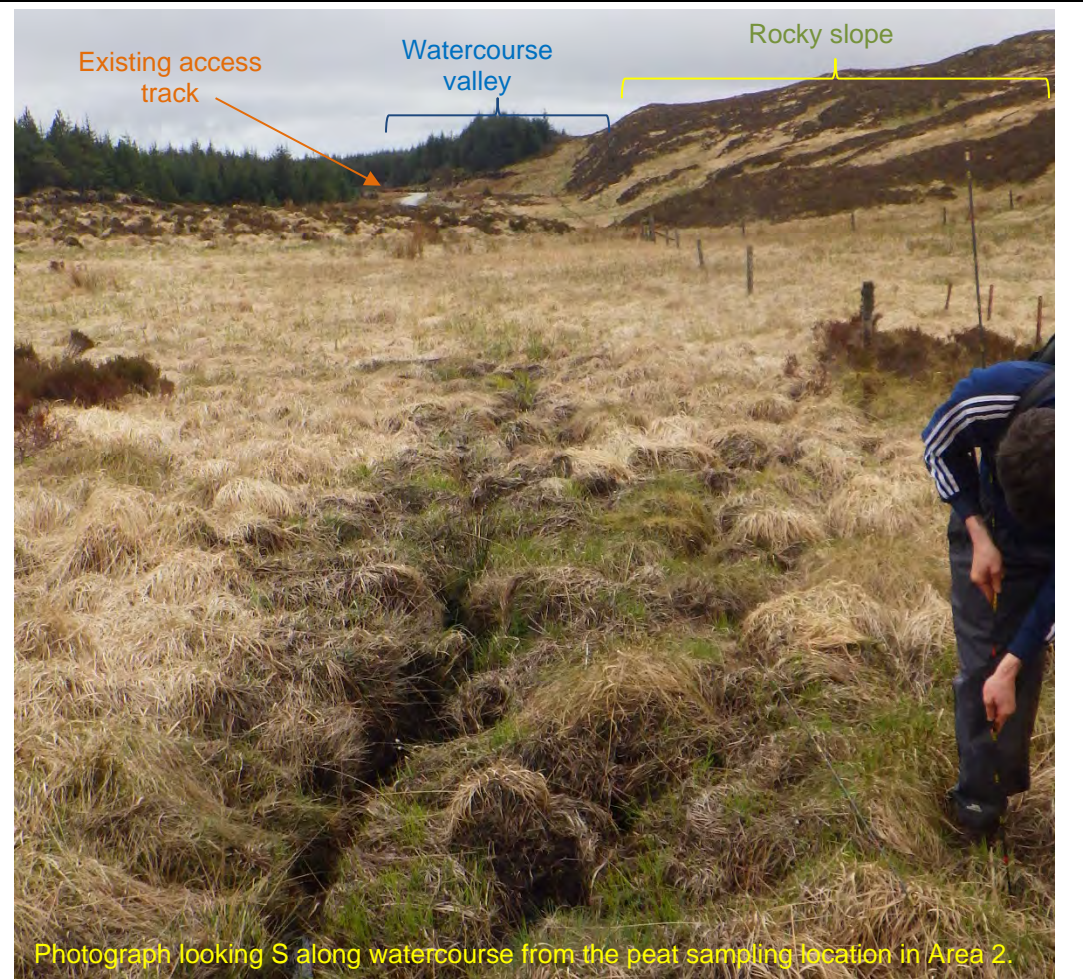
Photograph looking S along watercourse from the peat sampling location in Area 2.

Inspection of the photograph indicates that the slope to the west of the valley is steep but rocky, indicating that peat must be largely absent from this section. A peat depth of 2.8 m was recorded adjacent to the watercourse channel, within the flat boggy area within the valley floor where slope angles are very low.

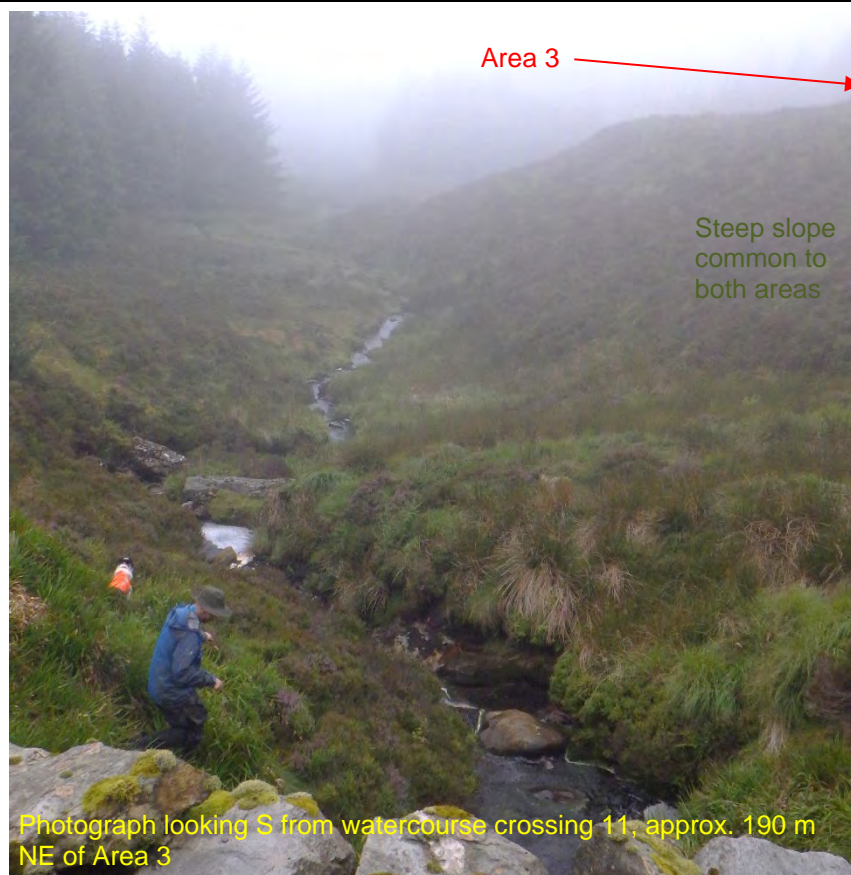
Photographs from nearby areas show the slope is comparatively steep and has the form of a river terrace (see photograph above). Depth records on the slope are all <0.5 m indicating that there is little or no peat on the slope. One peat depth record upstream of the highlighted cell has peat at 0.8 m above the main slope; a second record downstream, in a wide flat area, has peat at 1.35 m.

Calculated likelihood for both nearby peat records is Negligible. The nearest record directly on the slope, but further round from Area 3, has no peat.

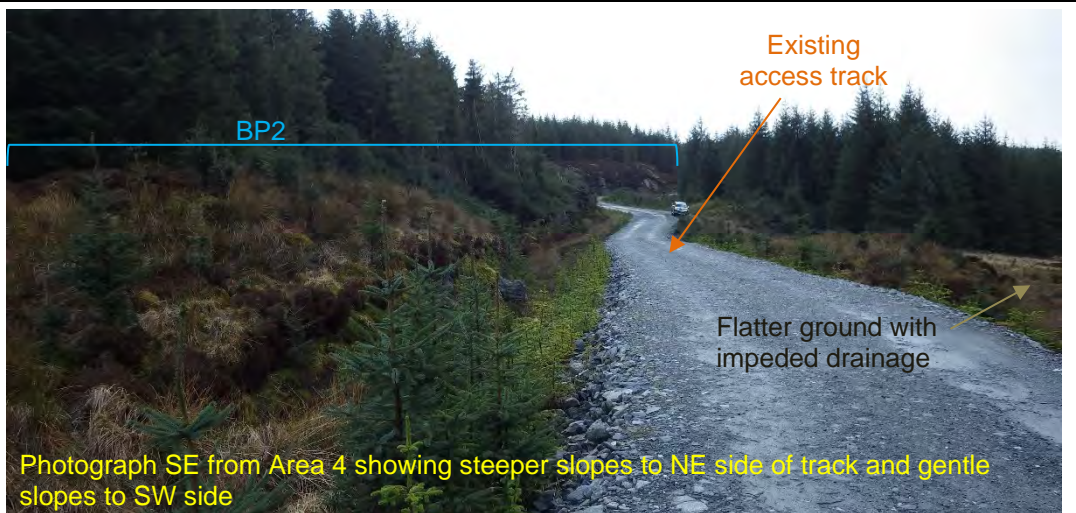
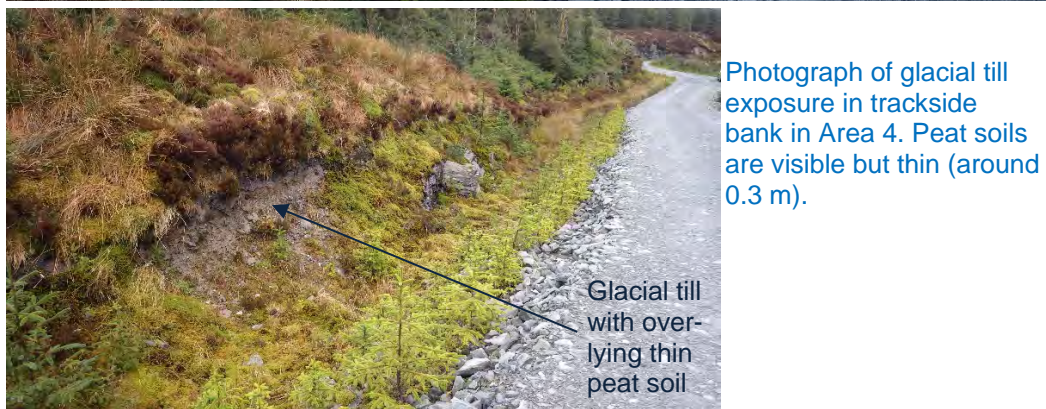
Photographs from the area show that peat to the north-east of the track is largely absent, with peaty soils around 0.3 m overlying glacial till (see above). Further south east, bedrock is exposed in the trackside bank. The recorded peat depth of 2.6 m was measured on the south-west side of the track, opposite the identified borrow pit, in an area with almost flat slope and impeded drainage. No signs of instability were observed in the area during site visits.

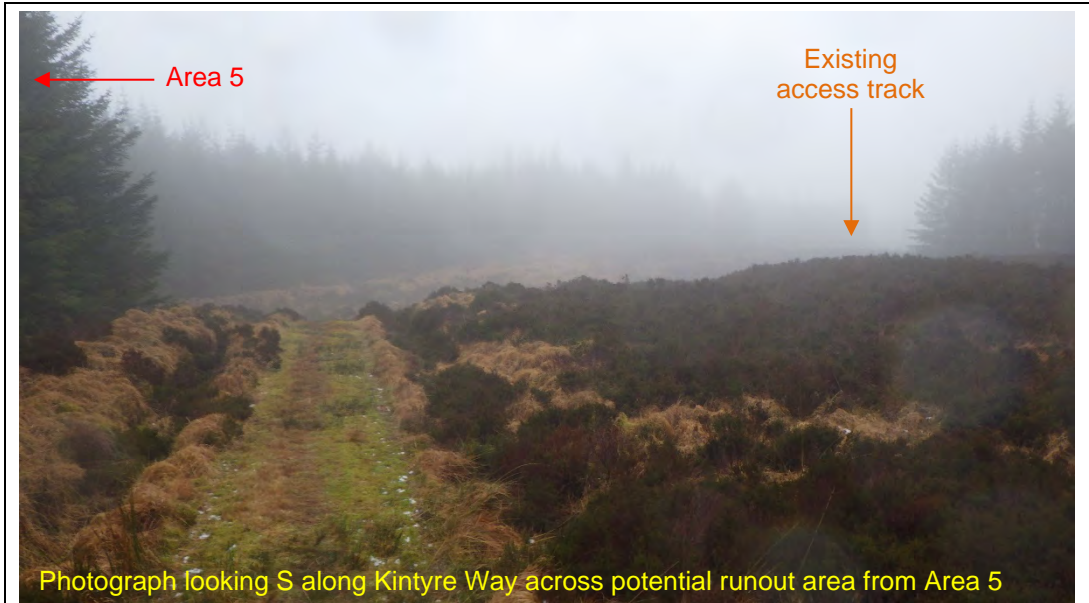
Photograph looking S along Kintyre Way across potential runout area from Area 5

Photographs from the area show that the ground is undulating with mainly gentle slopes. Peat depths are variable but generally <1 m. The short sections of steeper slope, as apparent in the photograph above are formed from shallow bedrock ridges, leading to small waterfalls in the nearby Allt Càrn Chaluim channel.

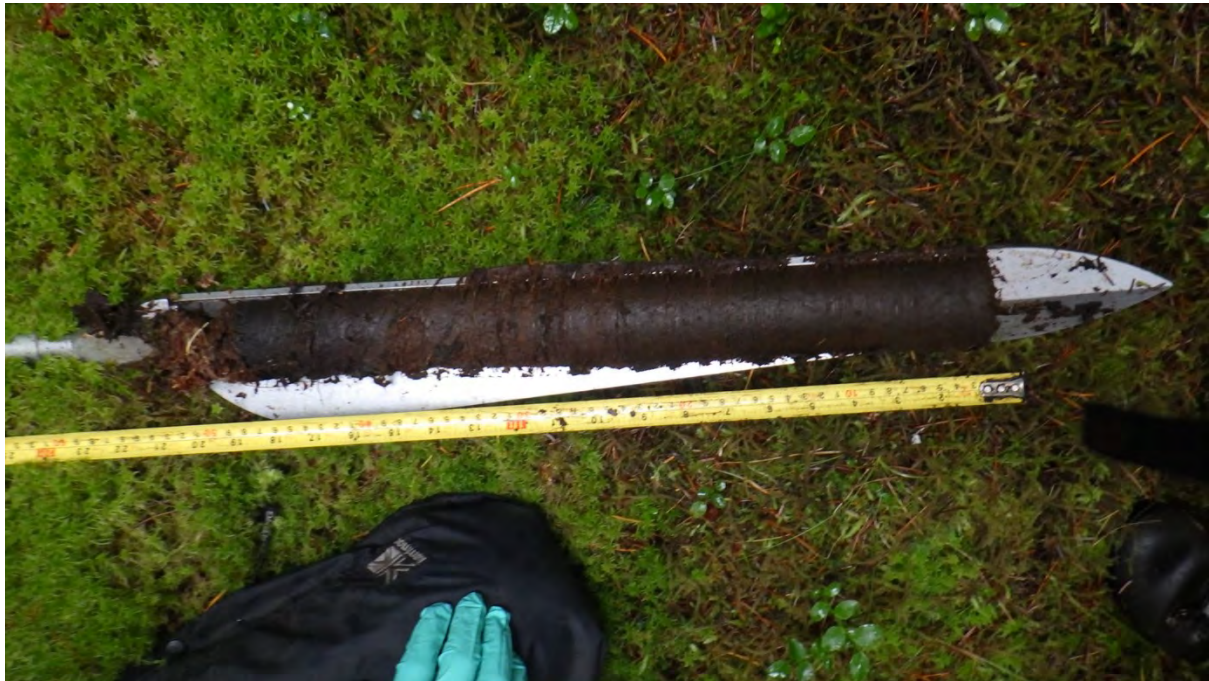
Notes: Coring section shows moderately highly decomposed peat overlying moderately decomposed peat with Sphagnum moss at surface.

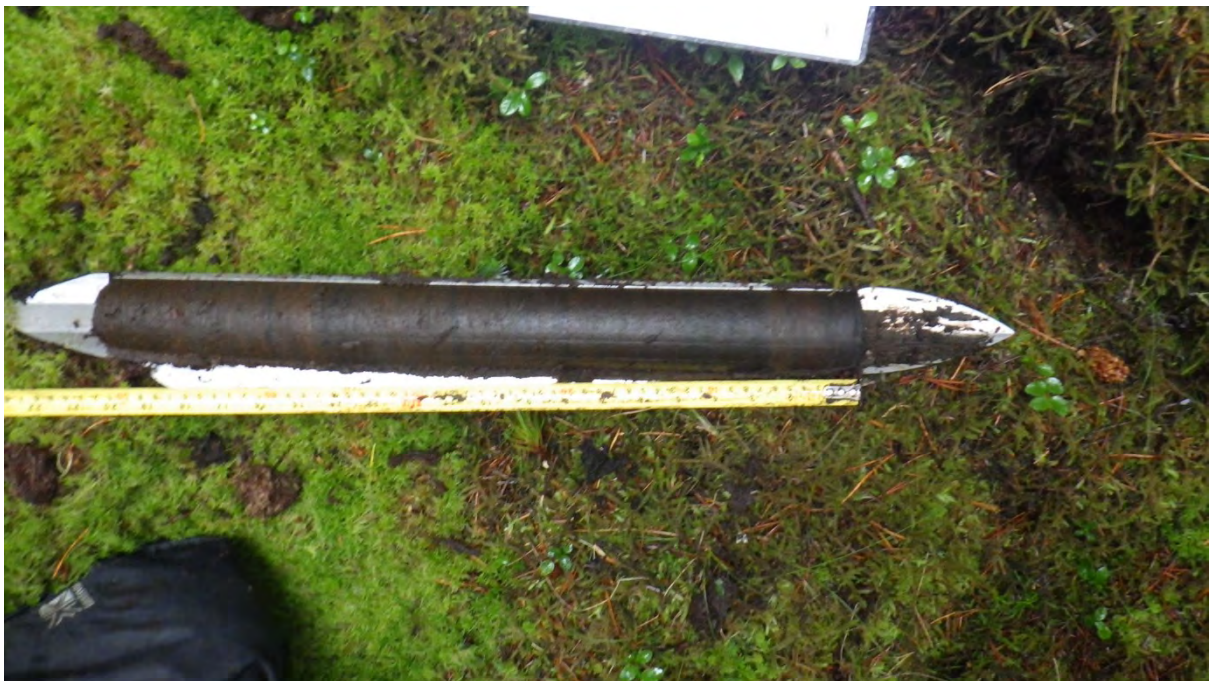
**Location: C1**

Notes: Interior of core sections showing primarily moderately decomposed peat, with a small amount of highly decomposed peat at the base.

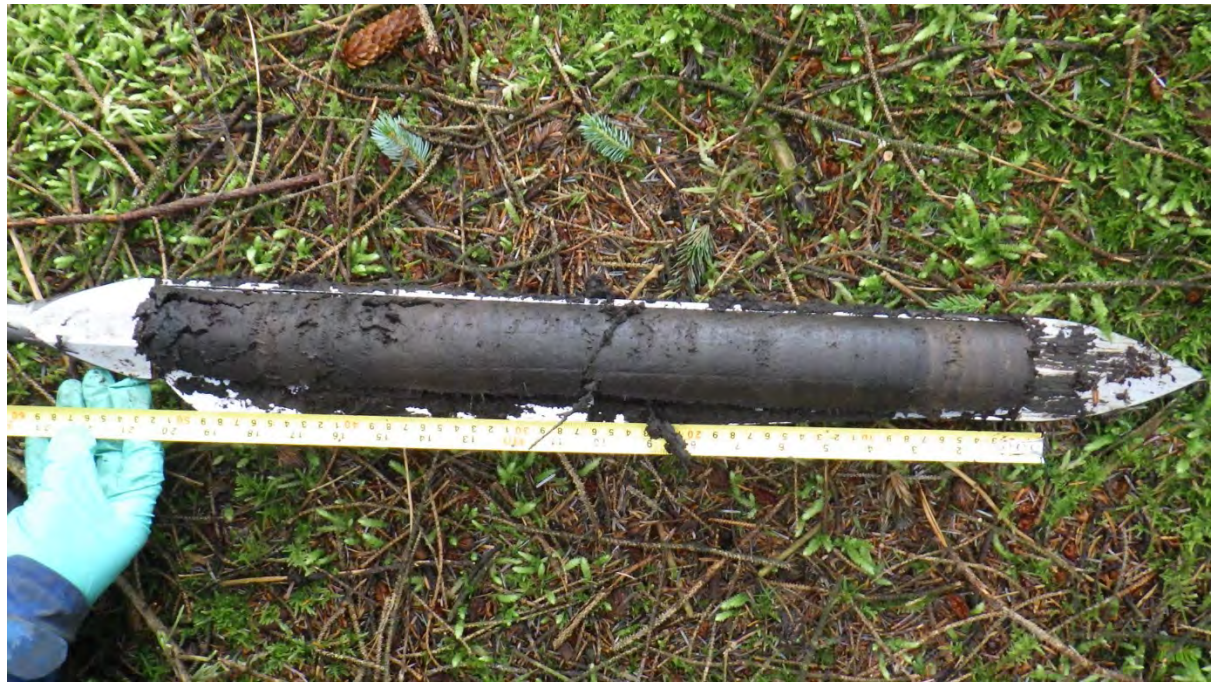
Location: C2

Notes: Core interior showing primarily highly decomposed peat. Some Sphagnum moss at the surface.

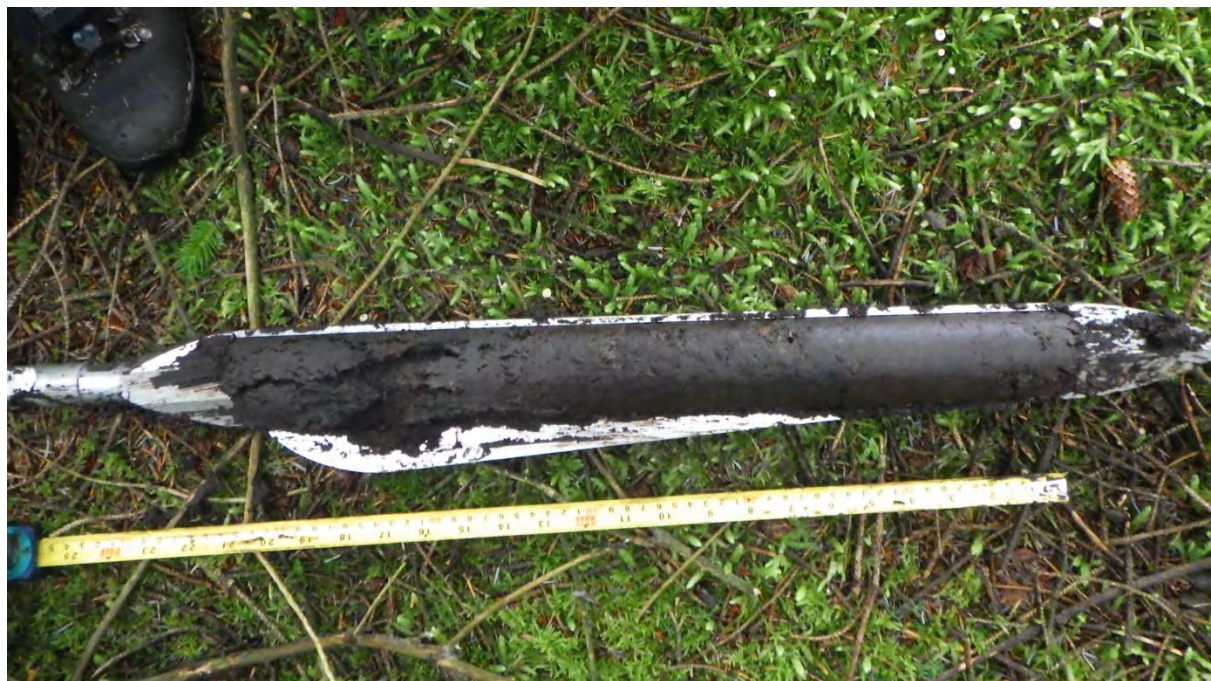
Location: C2

Notes: Core interior showing primarily slightly decomposed peat.

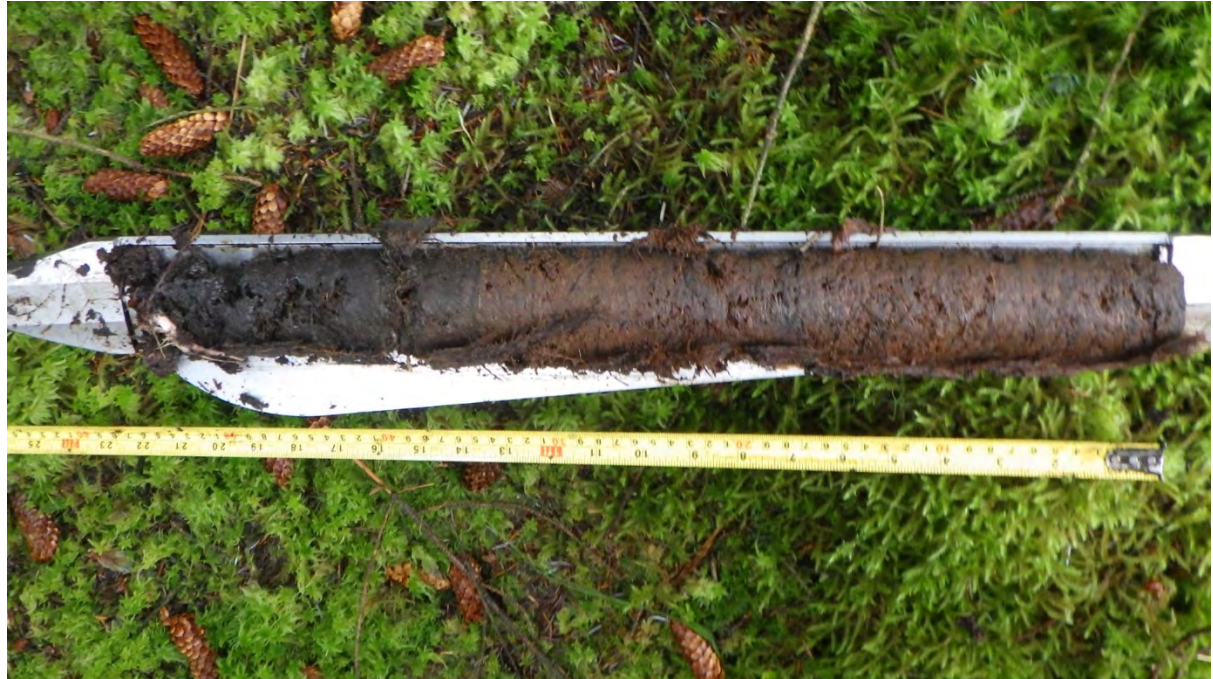
Location: C3	Depth: 0.00 – 0.50 m bgl	Date:07/08/2020
--------------	--------------------------	-----------------

Notes: Moderately highly decomposed peat with a very indistinct plant structure overlying very slightly decomposed reddish-brown peat with a strong network of interconnected roots.

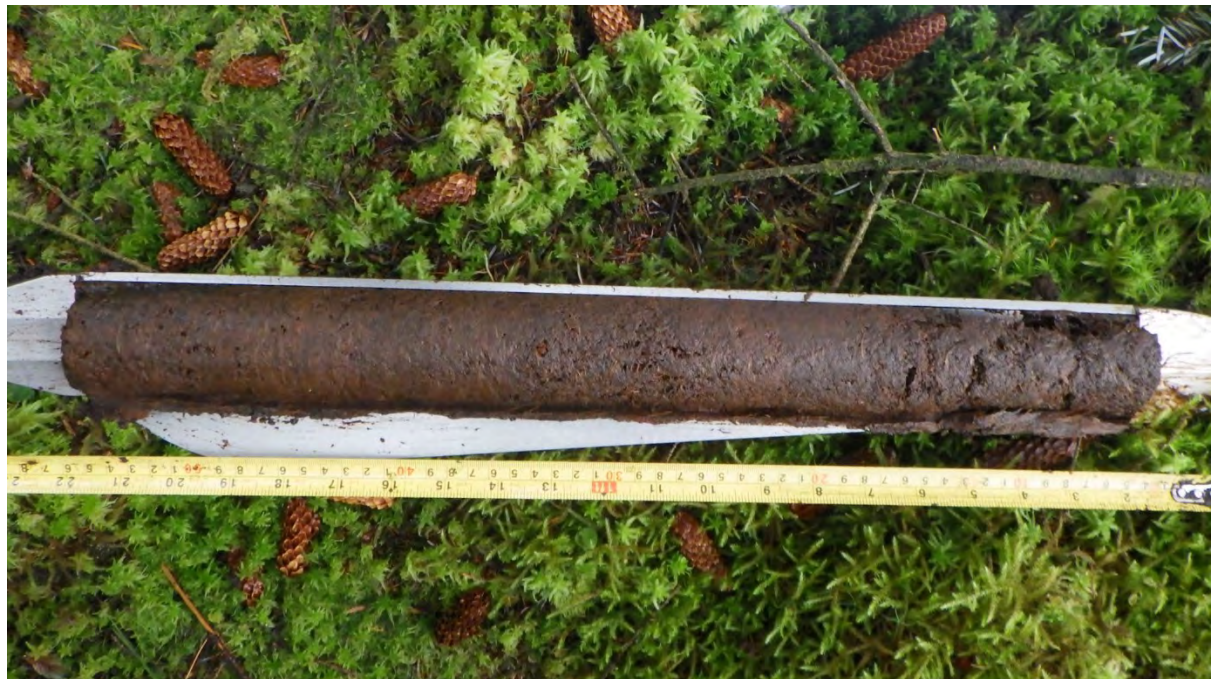
Location: C3	Depth: 0.50 – 1.00 m bgl	Date:07/08/2020
--------------	--------------------------	-----------------

Notes: Very slightly decomposed reddish-brown peat with a strong network of interconnected roots.

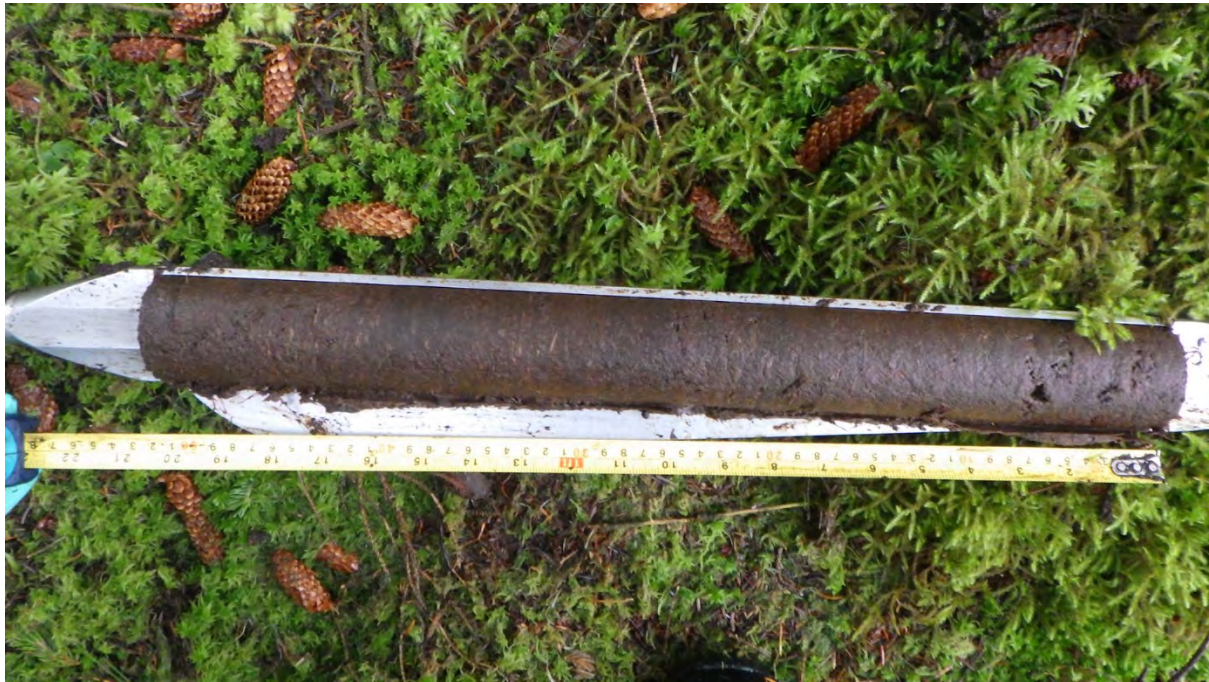
<b>Location: C3</b>	<b>Depth: 1.00 – 1.50 m bgl</b>	<b>Date:07/08/2020</b>
---------------------	---------------------------------	------------------------

Notes: Very slightly decomposed peat with a network of interconnected roots.

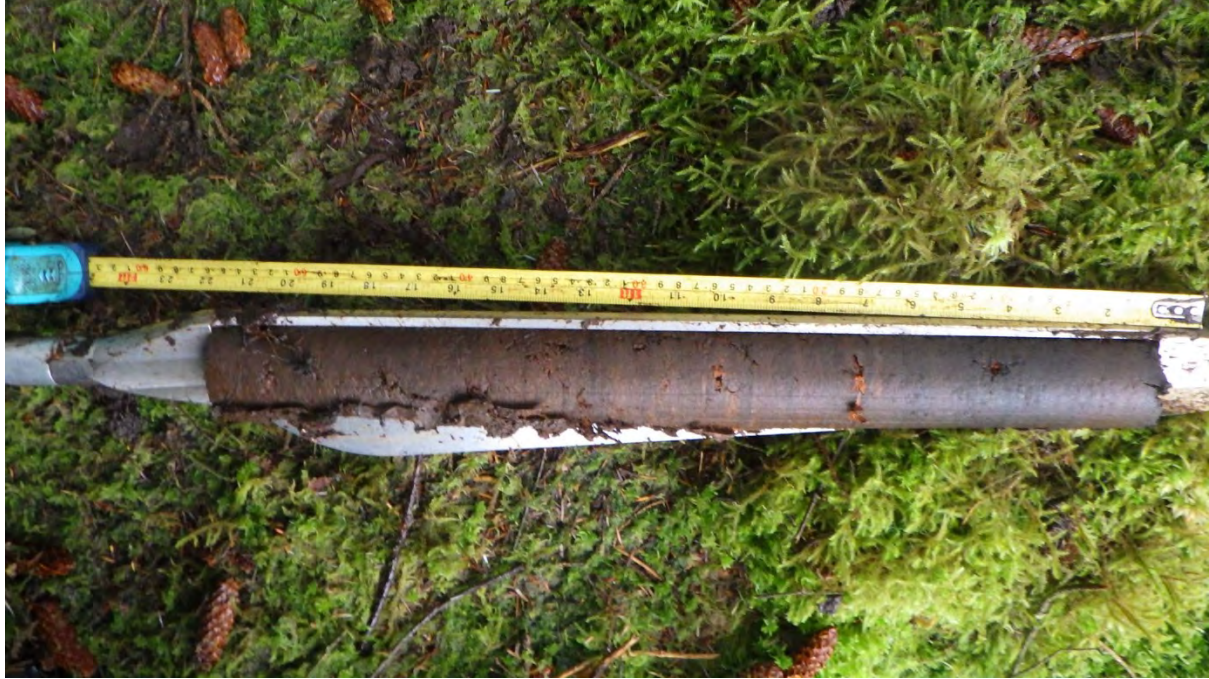
**Location: C3**

Notes: Moderately decomposed peat with some pieces of woody plant material.
