Cumberhead West Wind Farm
Environmental Impact Assessment Report
Figure 6.32 - Cumulative ZTV with Broken Cross, Broken Cross (small turbines) and M74 Eco-Park

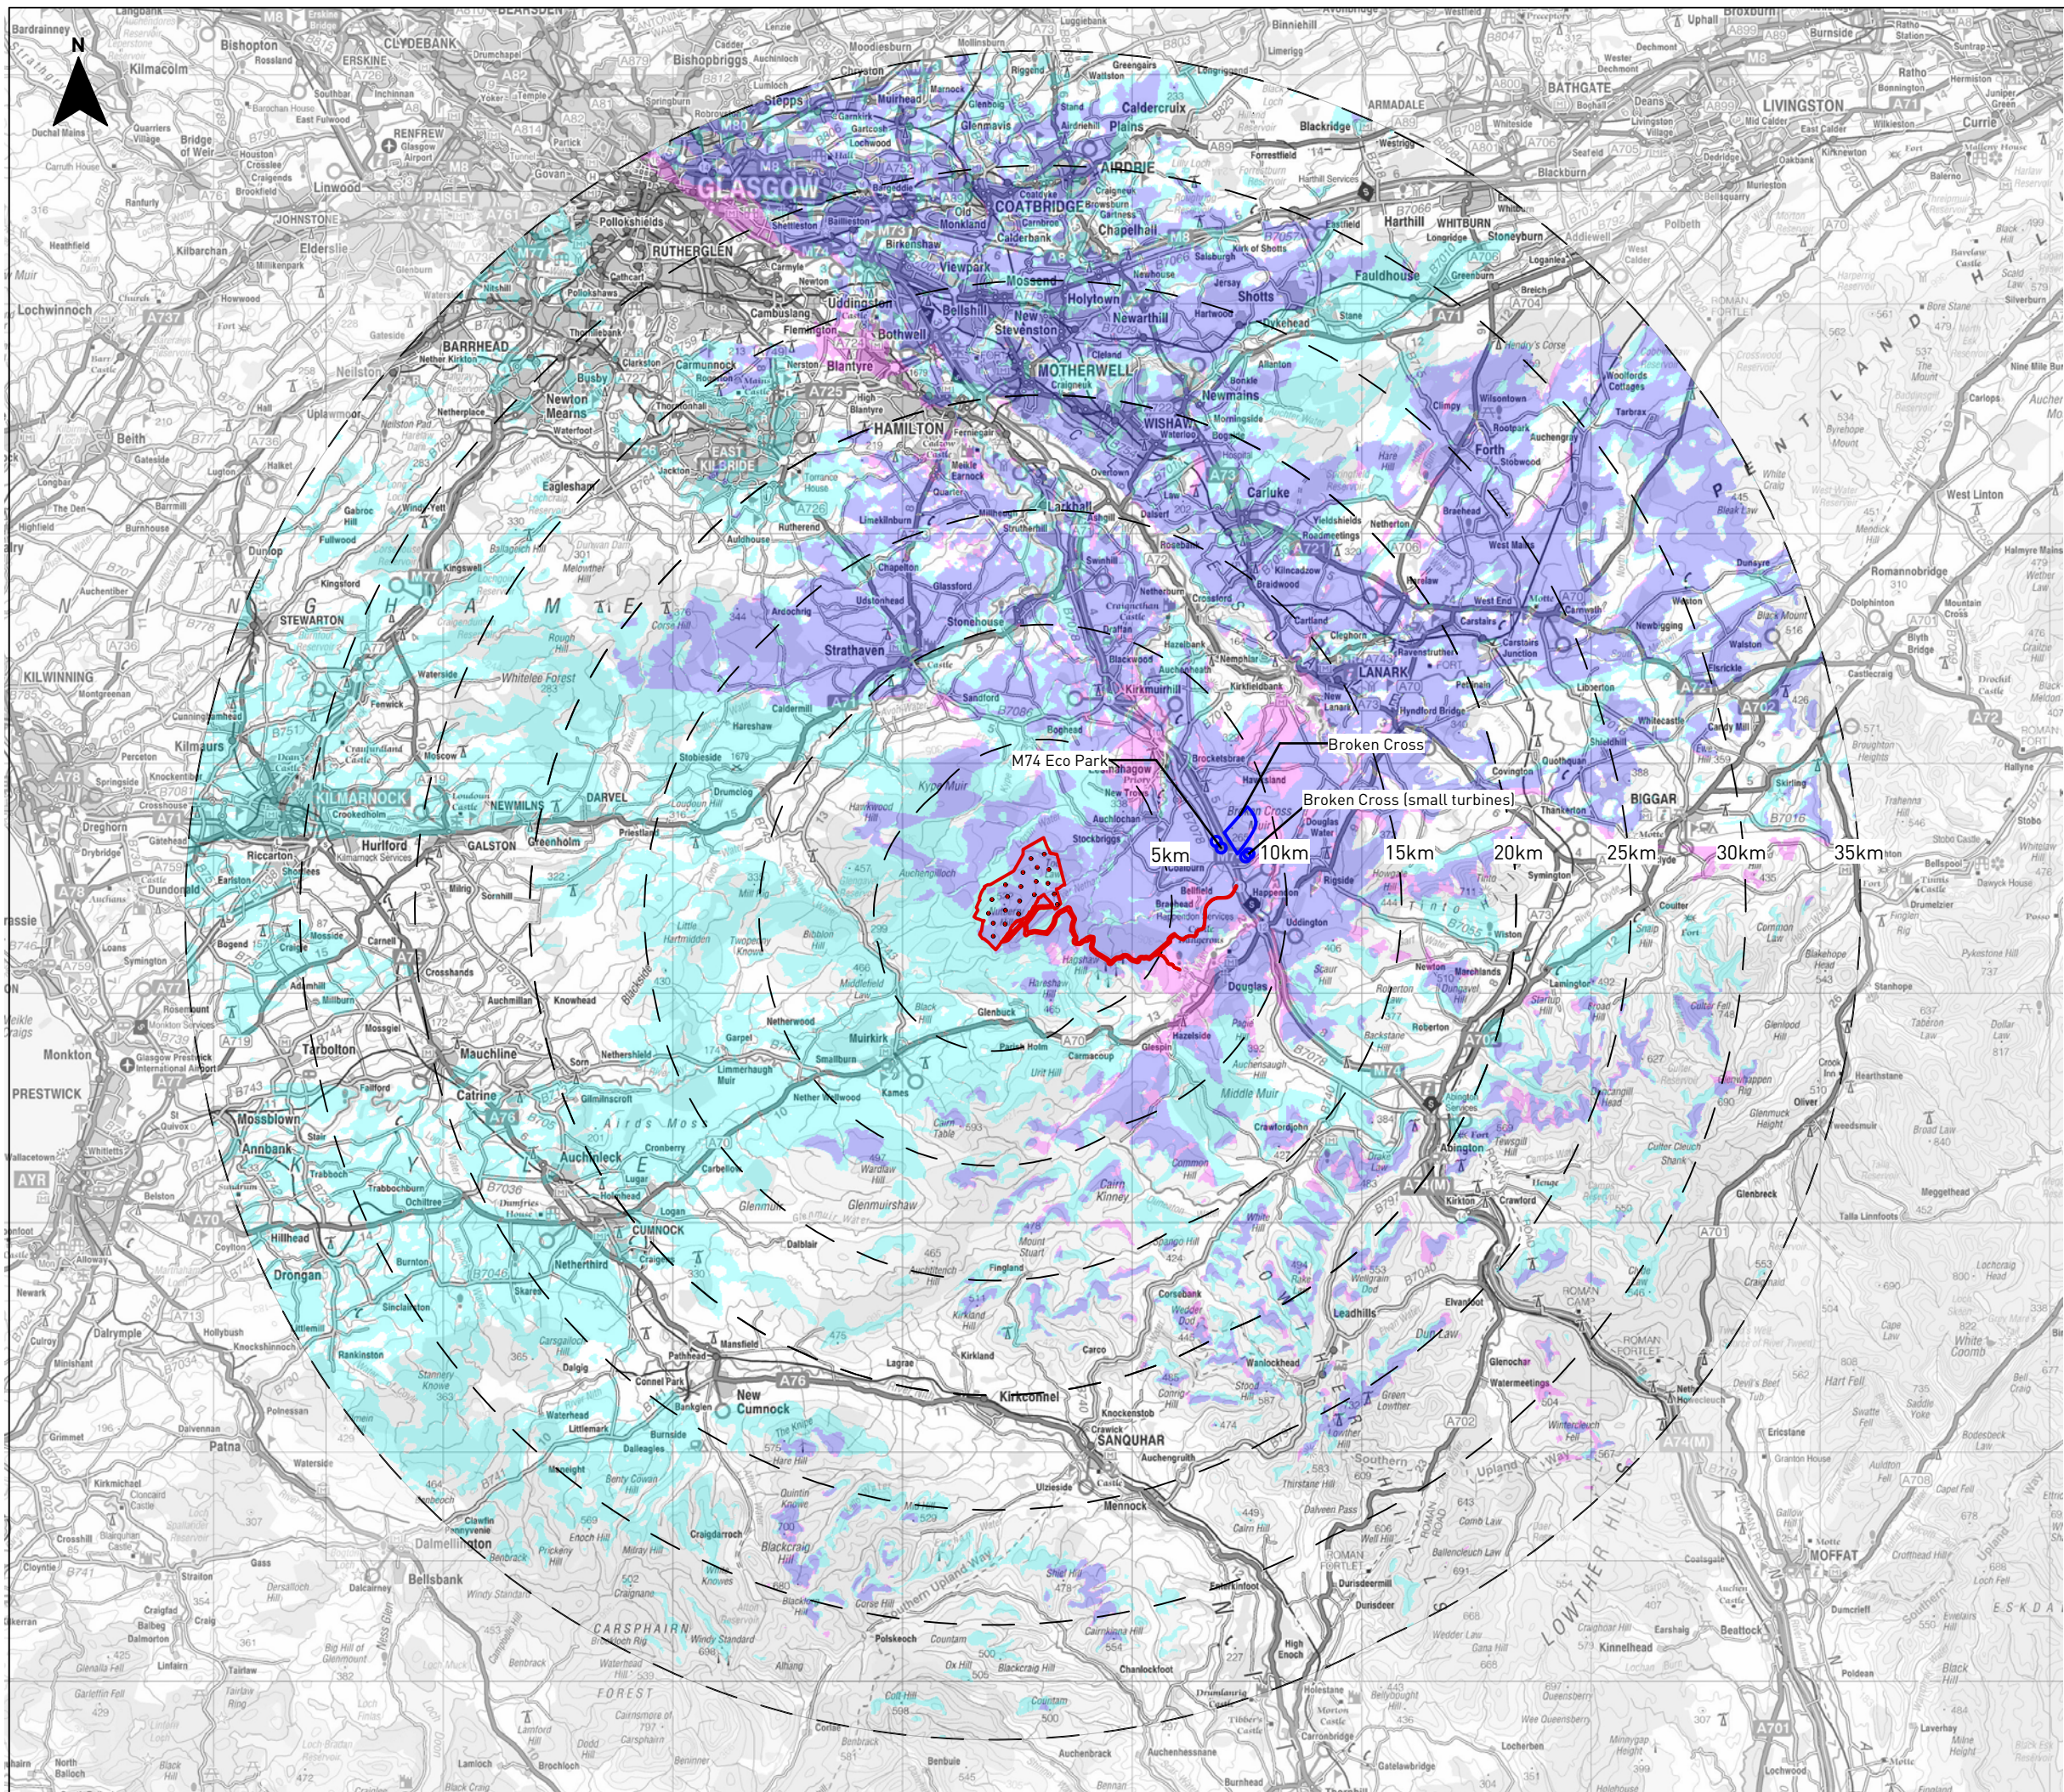
Wind farms theoretically visible

- Cumberhead West Wind Farm visible only
- Broken Cross, Broken Cross (small turbines) and/or M74 Eco-Park visible only
- Cumberhead West Wind Farm and Broken Cross, Broken Cross (small turbines) and/or M74 Eco-Park visible
