Technical Appendix 9.3

Baseline Noise Survey

Harestanes South Windfarm Extension Project Team

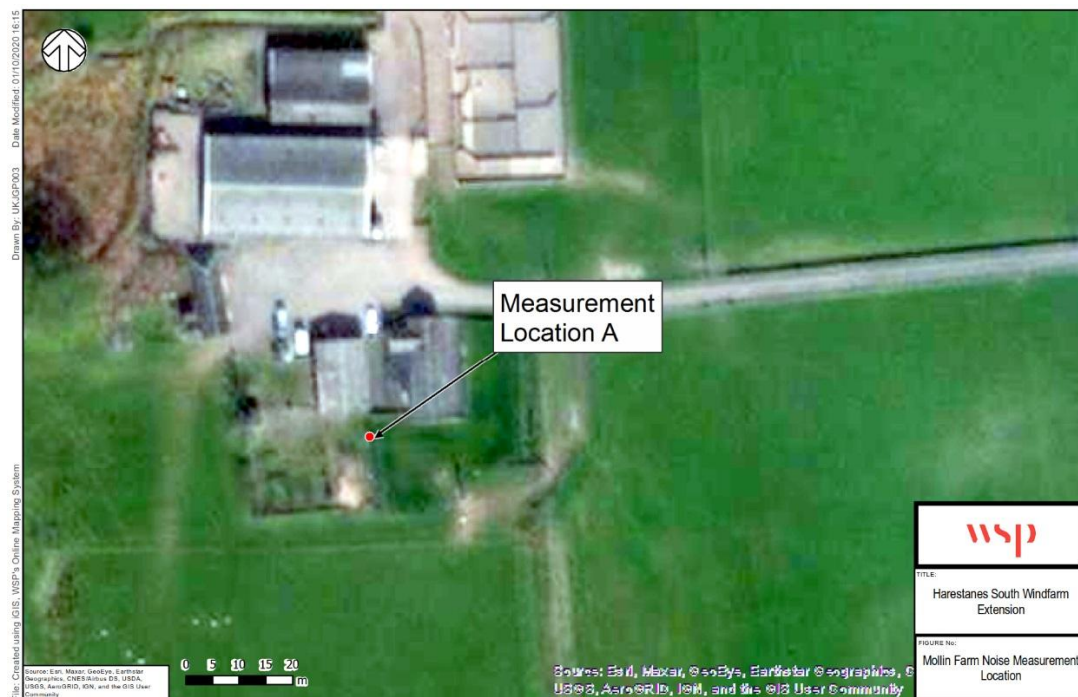
Figure 9.3.1: Measurement Location Plan

Site Information	
Location	Mollin Farm
Equipment Installation Location	OS Grid Reference
	X Y
	305248 53003
Installation	Microphone tripod mounted at 1.2m height. Windscreen and secondary windscreen installed. Secondary battery case connected.
Measurement Location	Installed on grass approximately 4.5m from façade of barn and 11m from façade of dwelling. Flue/extract pipe observed on roof of barn. Appears to be heating for barn and not active at time of installation.
Ambient Sound	Birdsong and noise from distant livestock and occasional distant agricultural machinery observed. Occasional distant shouts could be heard from sheep pens to the north east of the dwelling. Sporadic noise associated with farming activities can be expected e.g. from yard to the north.

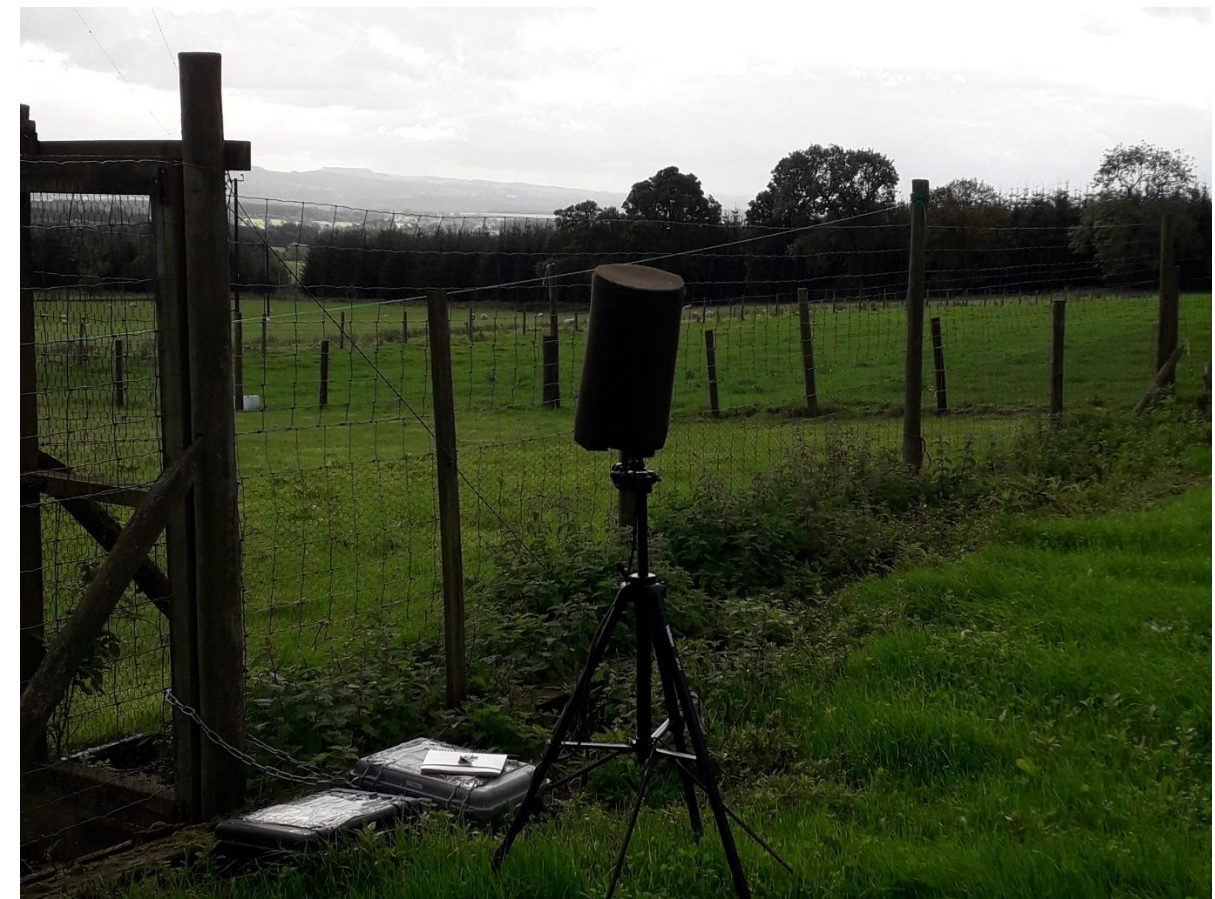
Photograph 9.3.1: Installed Measurement Location Looking South East

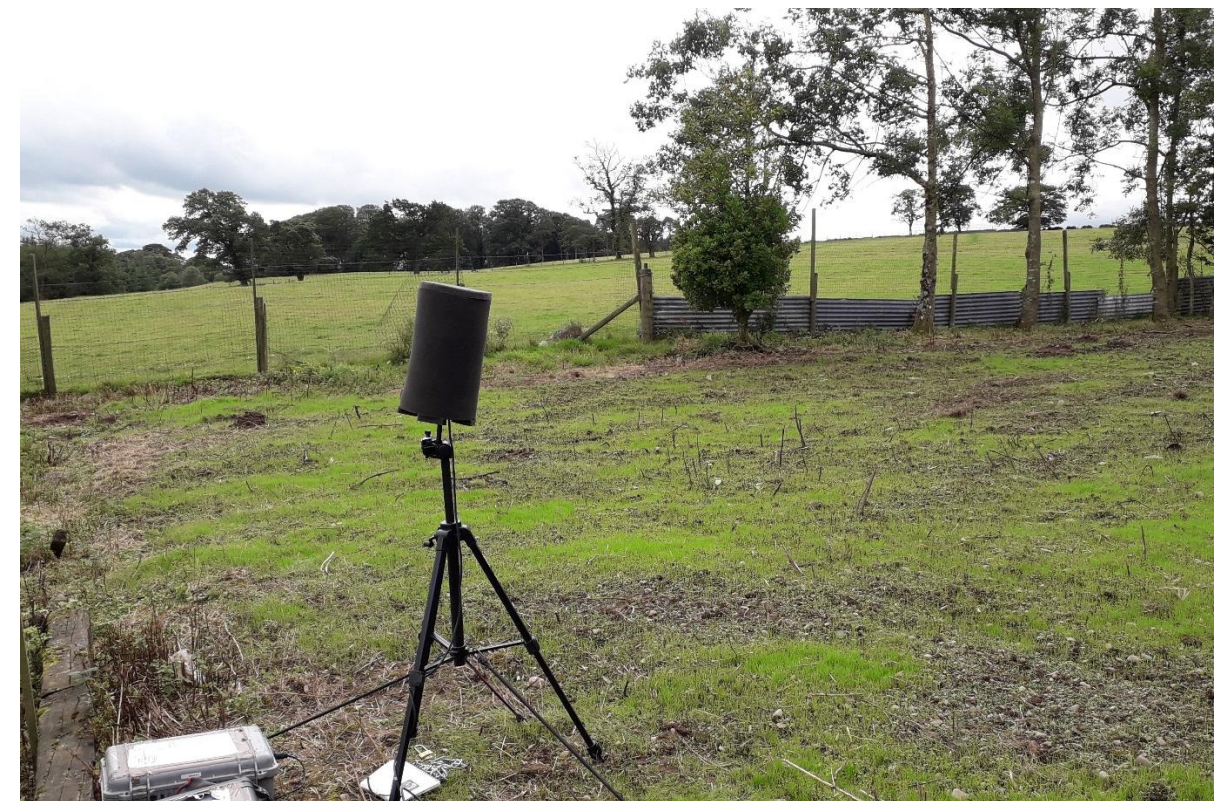
Photograph 9.3.2: Installed Measurement Location Looking South West

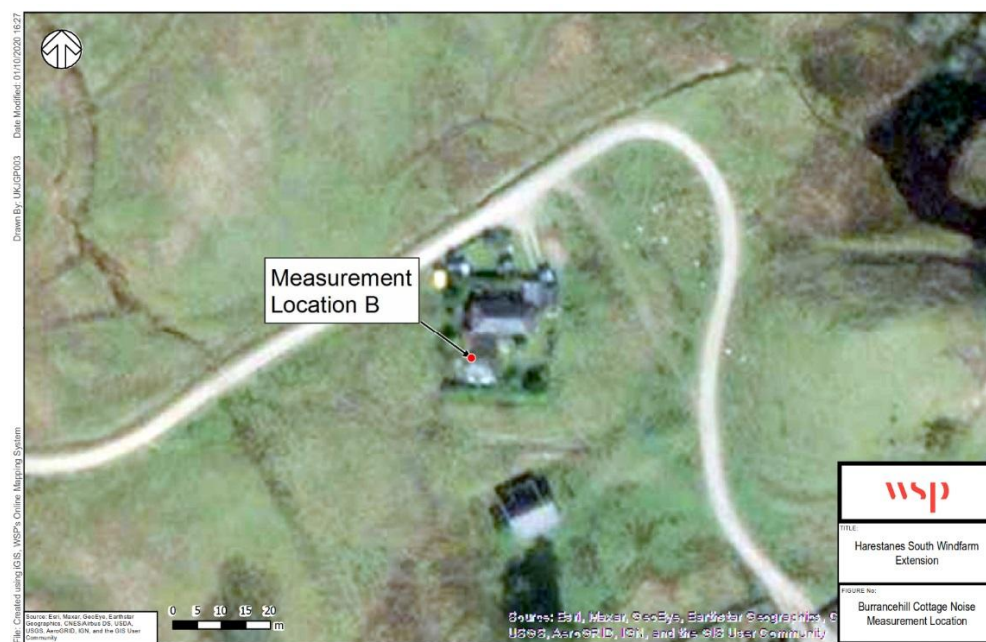
Figure 9.3.2: Measurement Location Plan

Site Information	
Location	Burrancehill Cottage
Equipment Installation Location	OS Grid Reference
	X Y
	304235 591234
Installation	Microphone tripod mounted at 1.2m height. WS-15 windscreen installed.
Measurement Location	Installed on gravel approx. 4.5m from south facing aspect of dwelling and 2.5m from hawthorn hedgerow.
Ambient Sound	Birdsong, and distant livestock were the main sources of sound. Occasionally just audible road traffic noise was observed from the direction of the A701. It was noted by the owner of the property that there were construction works being undertaken at the dwelling during the daytime hours only, but these fell outside the ETSU-R-97 quite daytime assessment hours. There were no works being undertaken at time of equipment install.

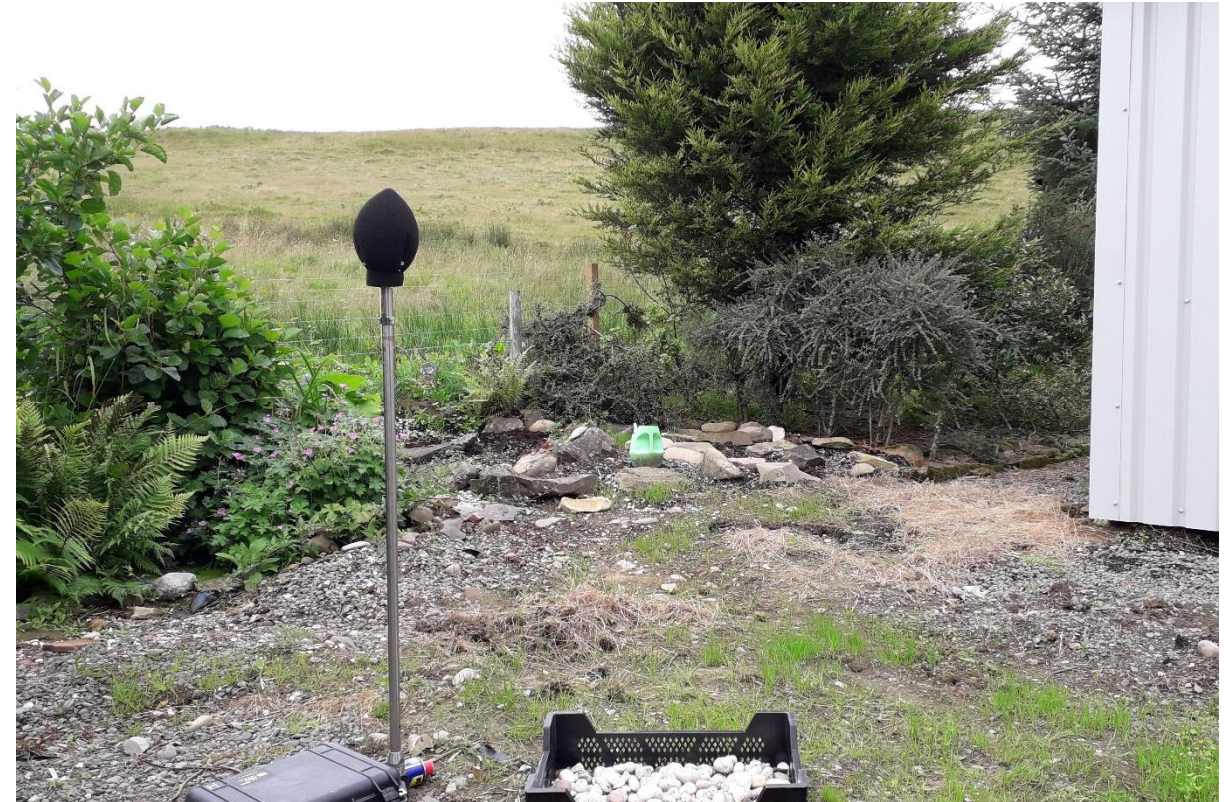
Photograph 9.3.3: Installed Measurement Location Looking North West.

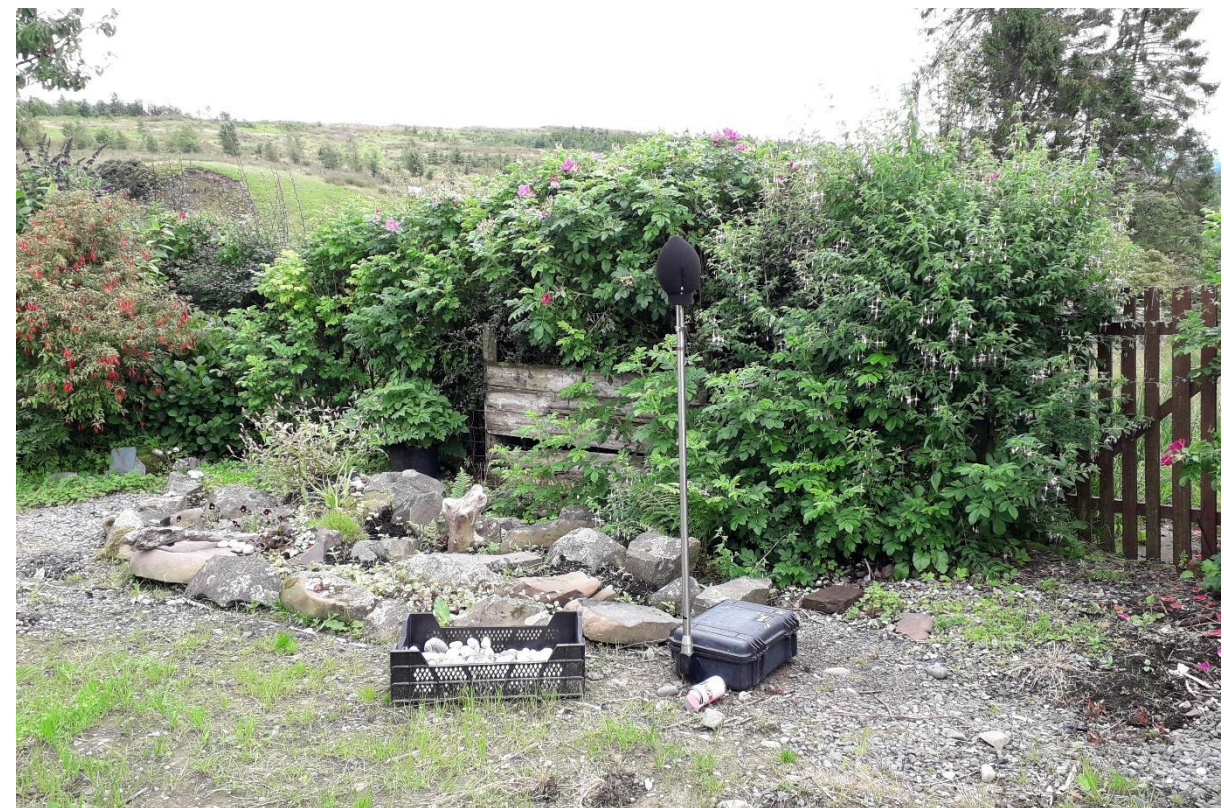
Photograph 9.3.4: Installed Measurement Location Looking South.

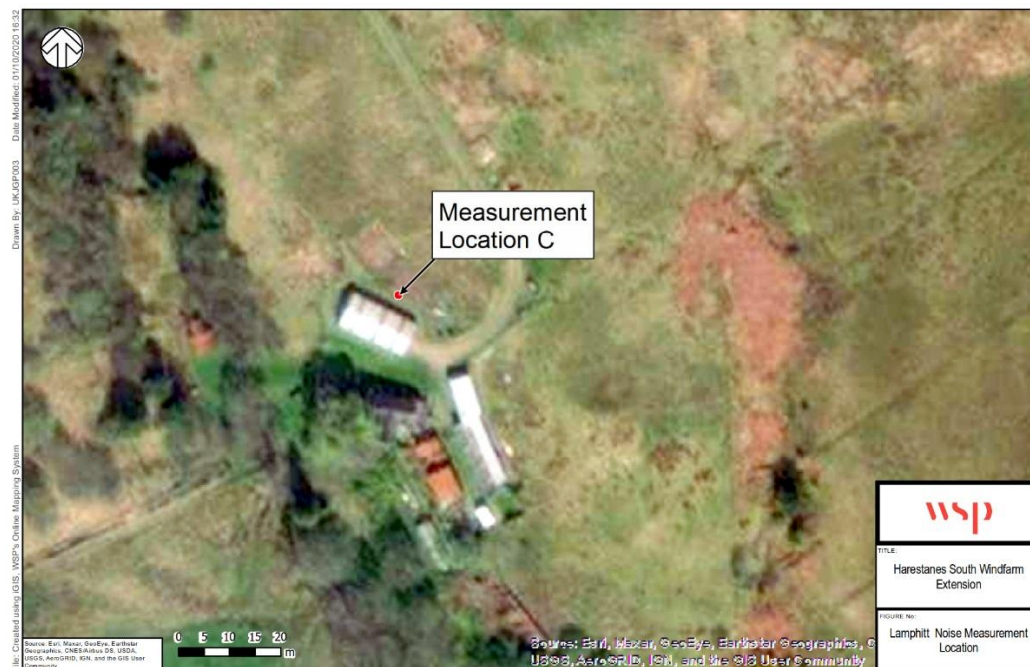
Figure 9.3.3: Measurement Location Plan

Site Information	
Location	Lamphitt
Equipment Installation Location	OS Grid Reference
	X Y
	299946 589743
Installation	Microphone tripod mounted at 1.2m height. WS-15 windscreen installed.
Measurement Location	Installed on grass approximately 5m from north east facing aspect of barn. Measurement Location selected to be screened from and at distance from watercourse by barn.
Ambient Sound	Birdsong, and distant sound of running water in watercourse. Watercourse is to the west of the residential dwelling and the barn. Measurement Location screened from watercourse by the barn such the measured levels are lower than those present at the external amenity spaces of the dwelling. Ambient sound at all other locations adjacent to the dwelling were influenced by the watercourse to a greater degree.

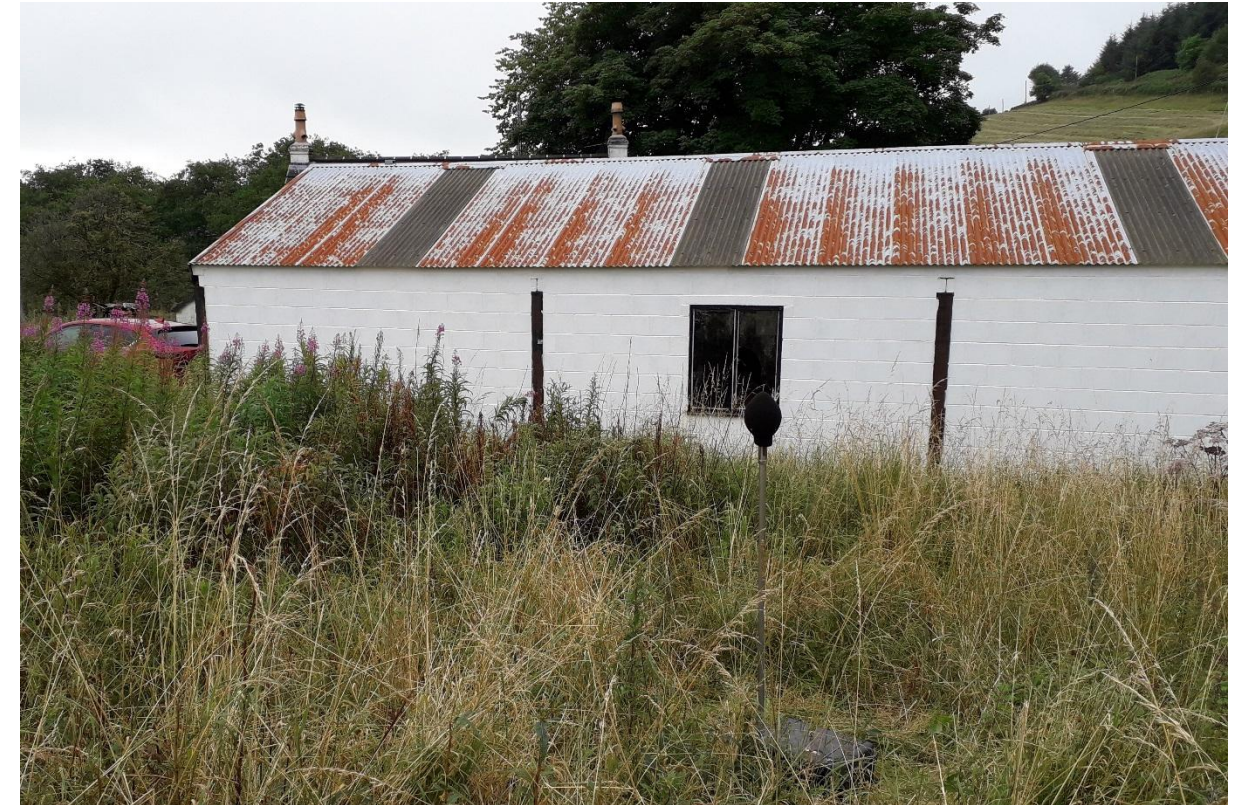
Photograph 9.3.5: Installed Measurement Location Looking South

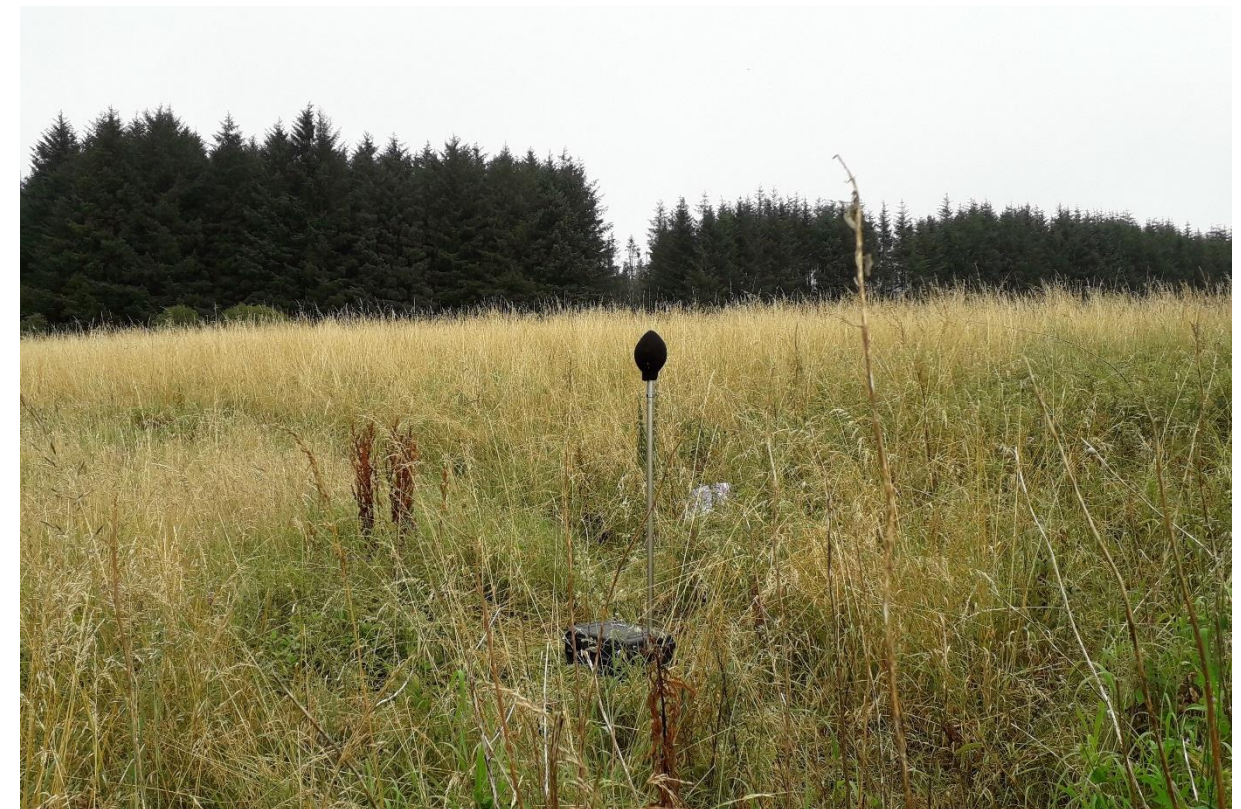
Photograph 9.3.6: Installed Measurement Location looking North West

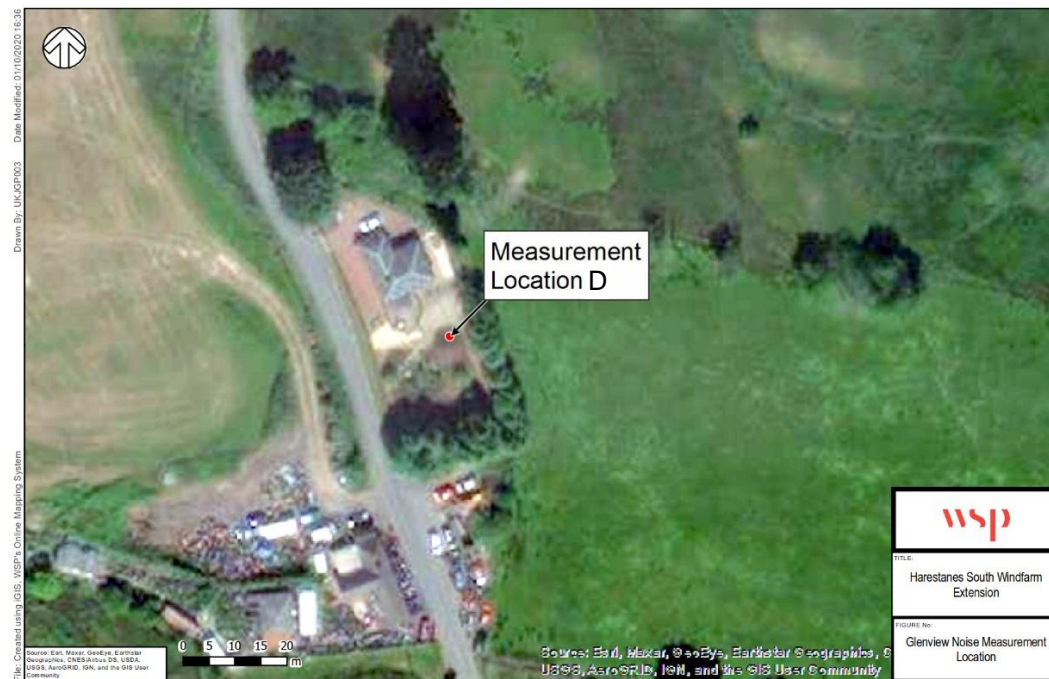
Figure 9.3.4: Measurement Location Plan

Site Information	
Location	Glenview
Equipment Installation Location	OS Grid Reference
	X Y
	297221 591642
Installation	Microphone tripod mounted at 1.2m height. Windscreen and secondary windscreens installed. Secondary battery case attached.
Measurement Location	Installed on grass approximately 8.5m from façade of dwelling conservatory and 3m from eastern boundary fence/hedge of garden. Hedge is comprised of conifer trees. No boiler flue on aspect closest to installation location.
Ambient Sound	Distant livestock, birdsong, and sound of trickling water from a water feature in the garden. This was noted to be 6m away from monitoring location. Option to install equipment on north east side of dwelling, but this would have been impacted to a greater degree by the sound of a running water in a stream to the north east of the property. Generally, distant sound of watercourses present across the property, but at a low level.

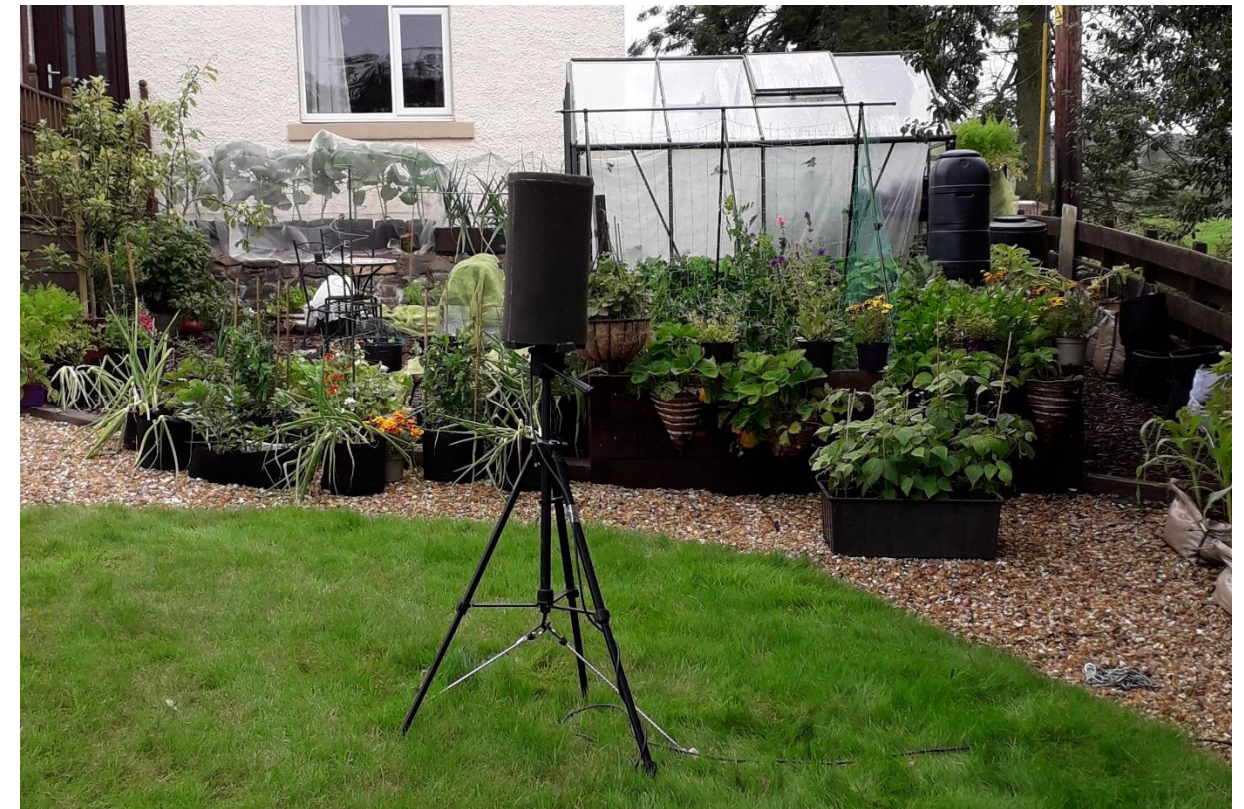
Photograph 9.3.7: Installed Measurement Location Looking North.

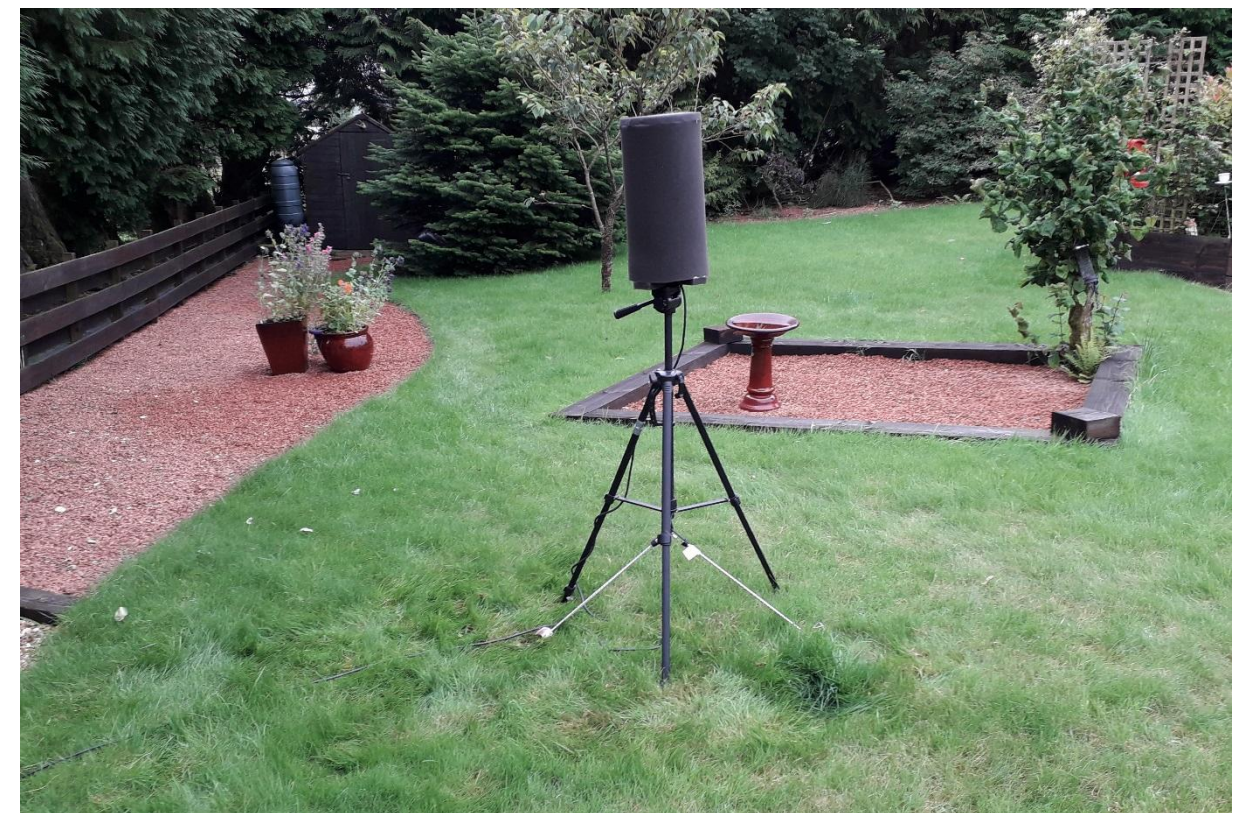
Photograph 9.3.8: Installed Measurement Location Looking South.

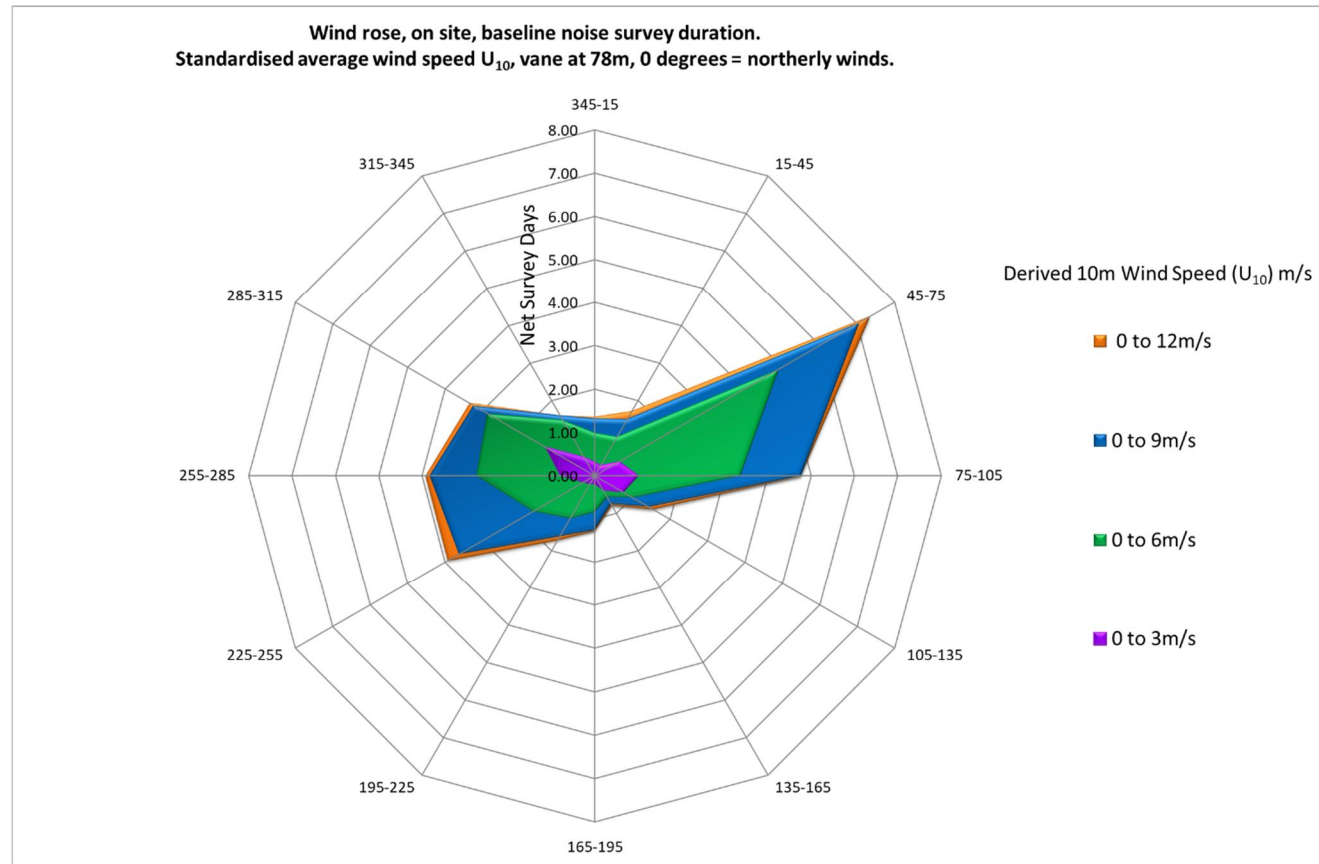
1. The following radar plot presents the proportion of the time that winds from different directions arose over the course of the baseline noise survey. The plot considers only the meteorological conditions during the ETSU-R-97 defined quiet daytime and night-time periods as utilised in the completed noise assessment.
2. The analysis considers the prevailing conditions for the period of the baseline noise survey, from its commencement to its conclusion.
3. The data is split into different wind speed ranges, based on average wind speeds at a standardised 10m height (U_{10}). The wind direction was taken from the vane installed at 78m height.

Plot 9.3.1: Wind Directions during Baseline Noise Survey
