# **Hollandmey Renewable Energy Development: Peat Slide Risk Assessment**

Technical Appendix 10.1

655098-P10.1 (04)

**Client:** ScottishPower Renewables

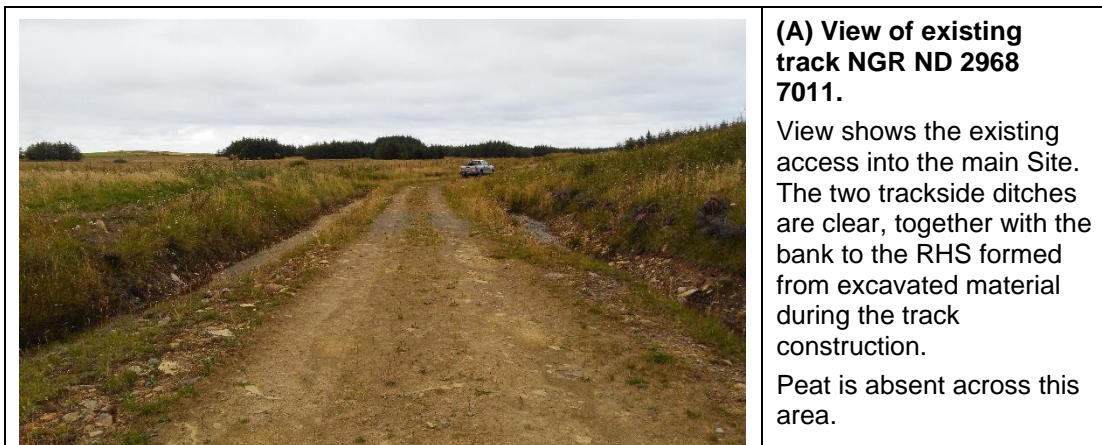
<p><b>(B) View of existing farm track giving access to solar array, NGR ND 2908 7120</b></p> <p>View shows the access route to the solar array and the southern margin of the solar array, with its rough vegetation.</p> <p>Peat is largely absent from this area, with only a few minor pockets identified in places. Peat depths are entirely below 1.0 m.</p>
 	<p><b>(C) View of forest margin near T08, NGR ND 2996 6938</b></p> <p>View shows transition from forestry plantation to open rough boggy grassland in the southern part of the Development.</p> <p>This area has deep peat in some sections, with depths to over 8 m.</p>
 	<p><b>(D) View of boundary ditch, NGR ND 2996 6935</b></p> <p>View east along a large ditch at the boundary of the Scoolary land parcel in the southern part of the Development.</p> <p>Much of this area has peat well in excess of 2 m in depth.</p>

<p><b>(E) Pasture field near T09, NGR ND 3013 6895</b></p> <p>One of the open fields within the Scoolary land parcel. View to the north showing the rough grassland in the boggy areas, giving way to the forestry plantation in the distance.</p> <p>Within the fields, peat is not present. Parts of the boggy grassland have deep peat well in excess of 2 m depth.</p>
	<p><b>(F) New ditch at forestry margin near T06, NGR ND 2937 6865</b></p> <p>View shows an open ride in the forestry with a newly excavated ditch. The ditch has been cut through the upper peat layer into soft clay below. Ride vegetation is mainly tussocky grass and heather.</p> <p>Peat depths in this area are variable but rarely over 1.5 m in depth.</p>
	<p><b>(G) View along the Link Burn, NGR ND 2864 6911</b></p> <p>View west along the Link Burn towards Lochend windfarm. This area is a broad open section within the forestry. The burn is in a slightly incised channel, mostly within the peat body. Ground is fairly boggy.</p> <p>Peat in this area is mainly over 2 m in depth but shallower areas are present in places.</p>

<p><b>(H) Vehicle track and forest ride near T02, NGR ND 2866 6983</b></p> <p>A vehicle access track with trackside drainage, and a typical forestry ride near T02. Vegetation is dominated by ling heather and rough grasses.</p> <p>The photo is from the margin of an area of deep peat towards an area with peat depths well over 2 m.</p>
	<p><b>(I) Open area near T02, NGR ND 2867 6973</b></p> <p>This open area forms the access to T02 and a proposed supporting borrow pit. Ground conditions are firm underfoot, with vegetation dominated by ling, sedges and tussock grass.</p> <p>The ridge in the centre has limited or no peat, although peat depths to either side are deeper (&gt;2 m).</p>
	<p><b>(J) Fire break between T02 and T05, NGR, ND 2923 6965</b></p> <p>Typical view of an open area and drainage ditch within the main forestry area; this example is between Turbines 2 and 5. Ground conditions are dominated by tussock grass and moss.</p> <p>Peat in this area is deep, mainly over 3.0 m. Ground surface is almost flat.</p>

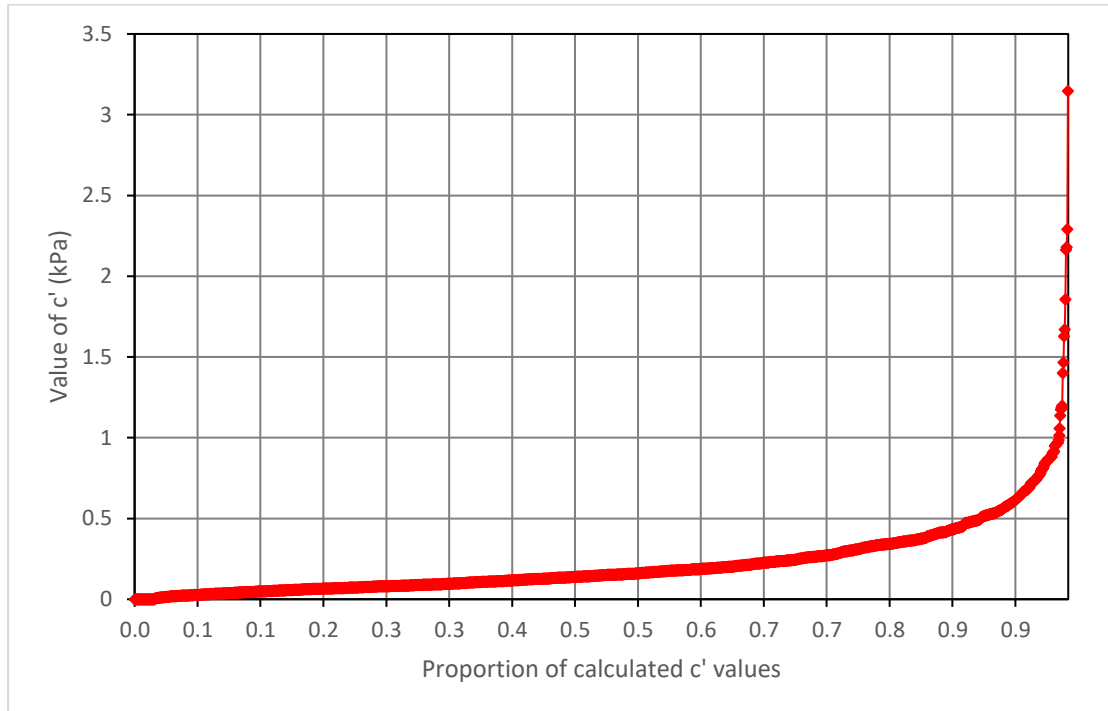
**Figure 10.1.1: Estimate of minimum shear strength,  $c'$**

- 6.9 At the Site, 1,484 locations have been probed during the phases of fieldwork.  $c'$  values have been calculated for each of these and the distribution is provided in **Figure 10.1.1**.

- 6.10 As the slopes at Hollandmey are naturally very gentle, the minimum required shear strength for the peat probing locations are comparatively low and are lower than usual quoted shear strength in peat. It is very likely, therefore, that this value for  $c'$  is a significant underestimate of the actual shear strength. Preliminary calculations indicated that using this value gave an unrealistic picture of the site-wide risks; as a result, the lowest published value for shear strength, 4.5 kPa, has been used in the analysis instead of the back-calculated values as it is considered that this will give a more representative assessment of risk while still remaining conservative.

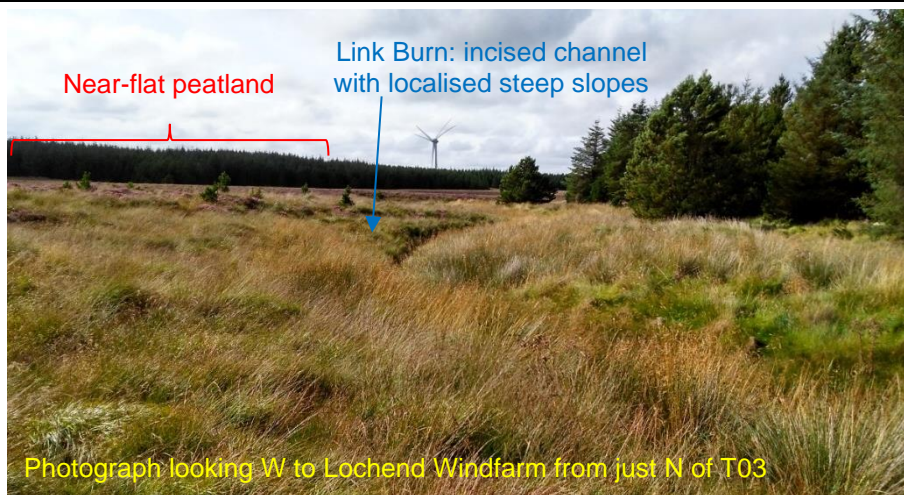
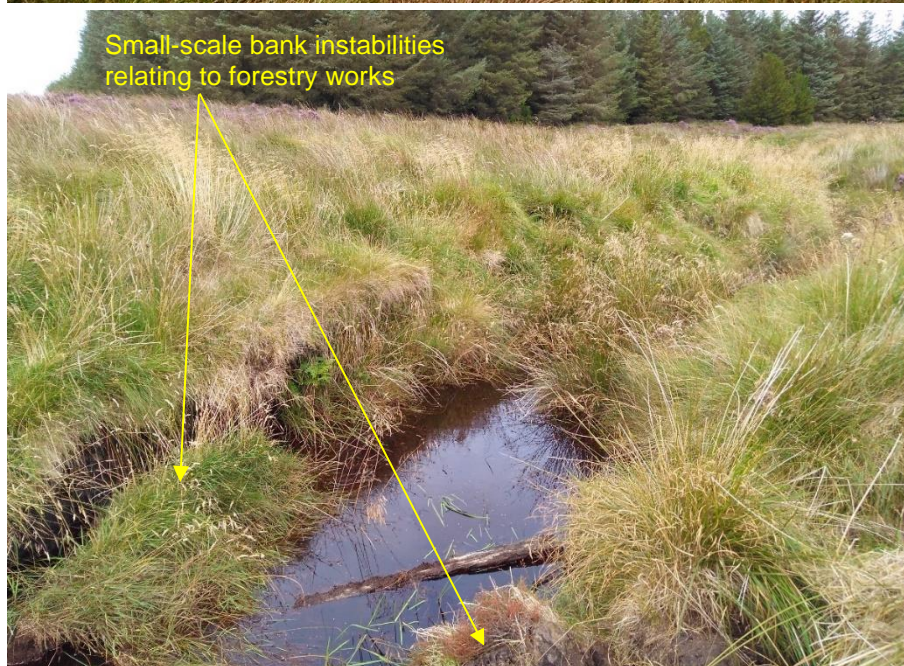
Photograph looking upstream along Burn of Hollandmey immediately SE of T02

No indications of peat landslides were observed along any of the watercourse channels. Small-scale bank instabilities are apparent in some areas, potentially associated with forestry works although they may be naturally occurring. Further small-scale bank instabilities can be expected as a result of natural undermining of banks by water movement, particularly at times of higher water level and flow velocity. However, along-channel slopes are almost flat and are therefore insufficient to allow momentum to build up along the watercourse channels. In the event of any instability, there would be a localised impact on the watercourse but limited wider impacts to the peatland, the hydrological environment or the Development

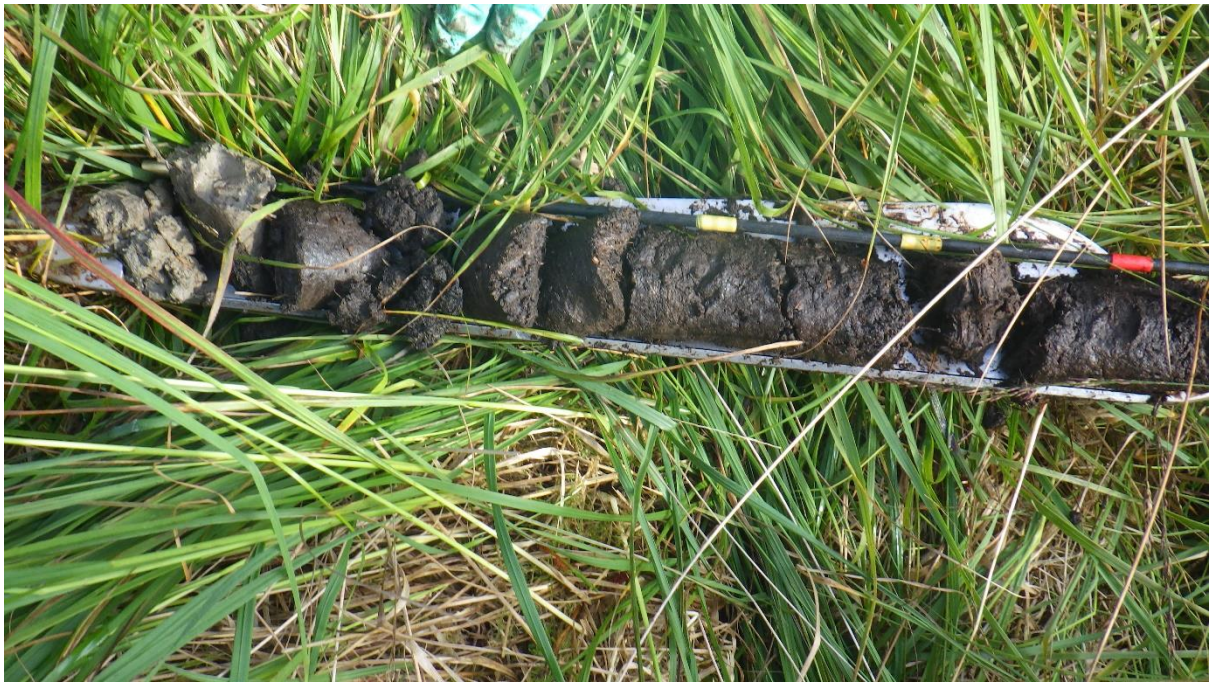
Location: C1A	Depth: 0.00 – 0.50 m bgl	Date: 24/09/2020
---------------	--------------------------	------------------

Notes: View showing interior of core sections. Primarily moderately decomposed peaty soils overlying clay at base (left of photo)

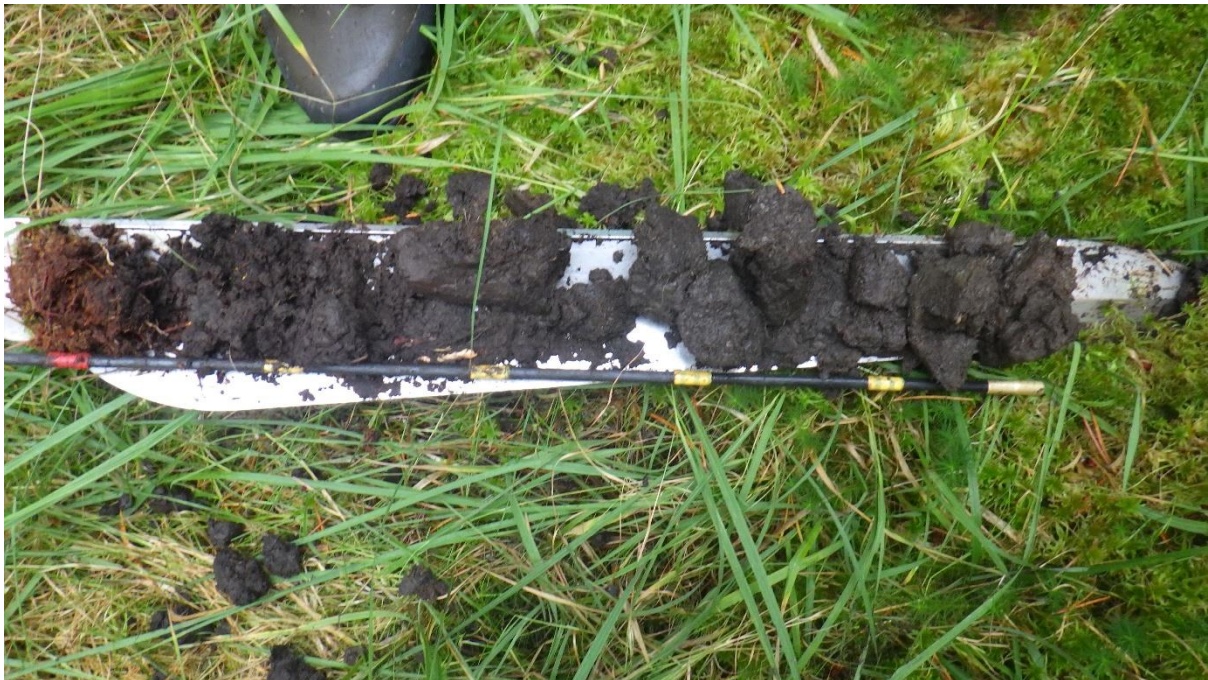
Notes: Core interior showing fibrous surface layer overlying primarily moderately decomposed peat with some recognisable plant structures.

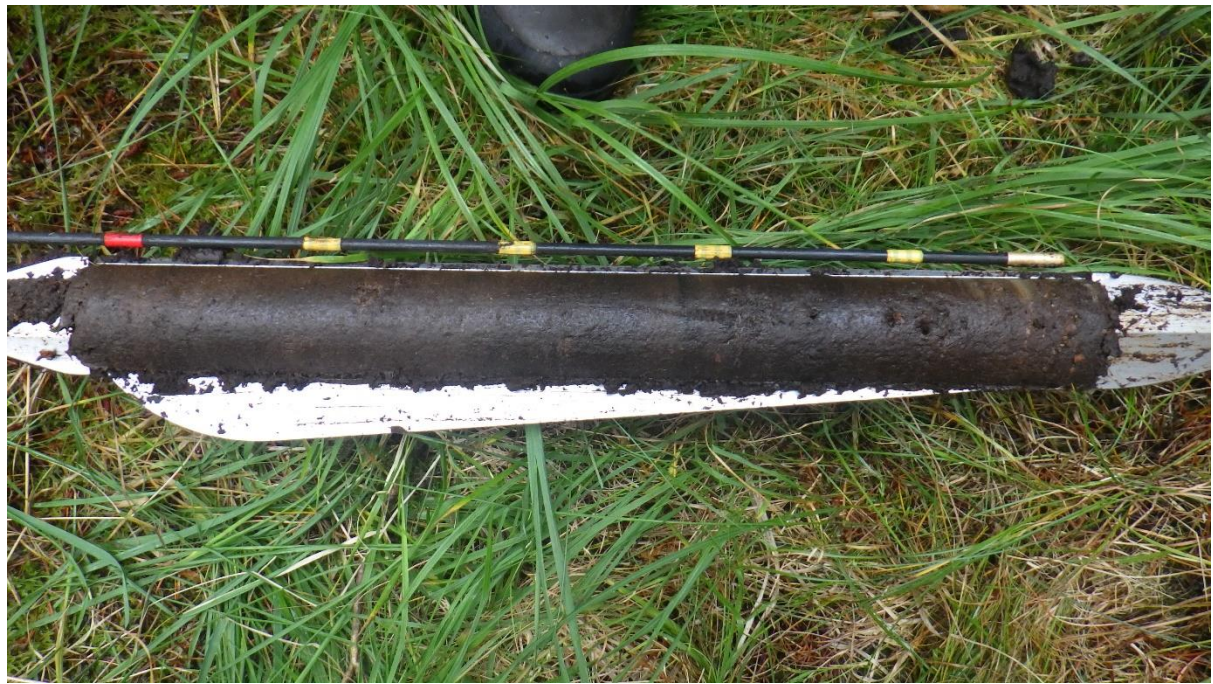
Notes: Moderately/highly decomposed peat, plant fragments visible in core at base (right of photo).

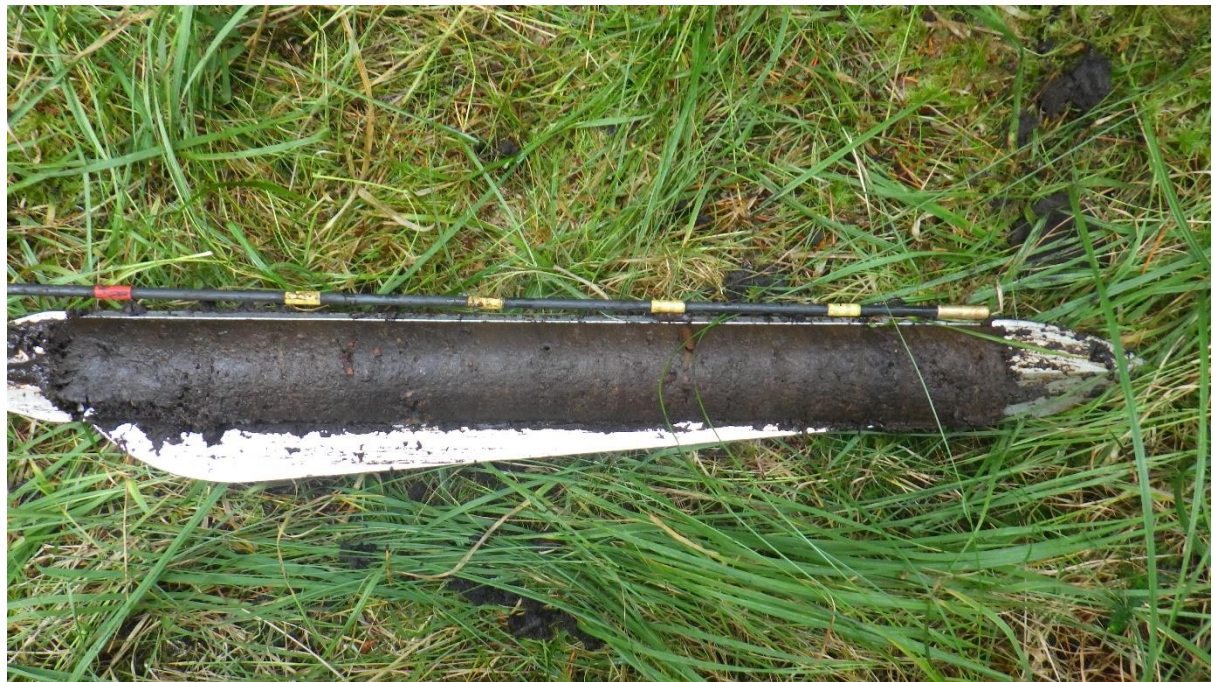
Notes: Moderate/highly decomposed peat with very occasional larger wood fragments which are very soft.

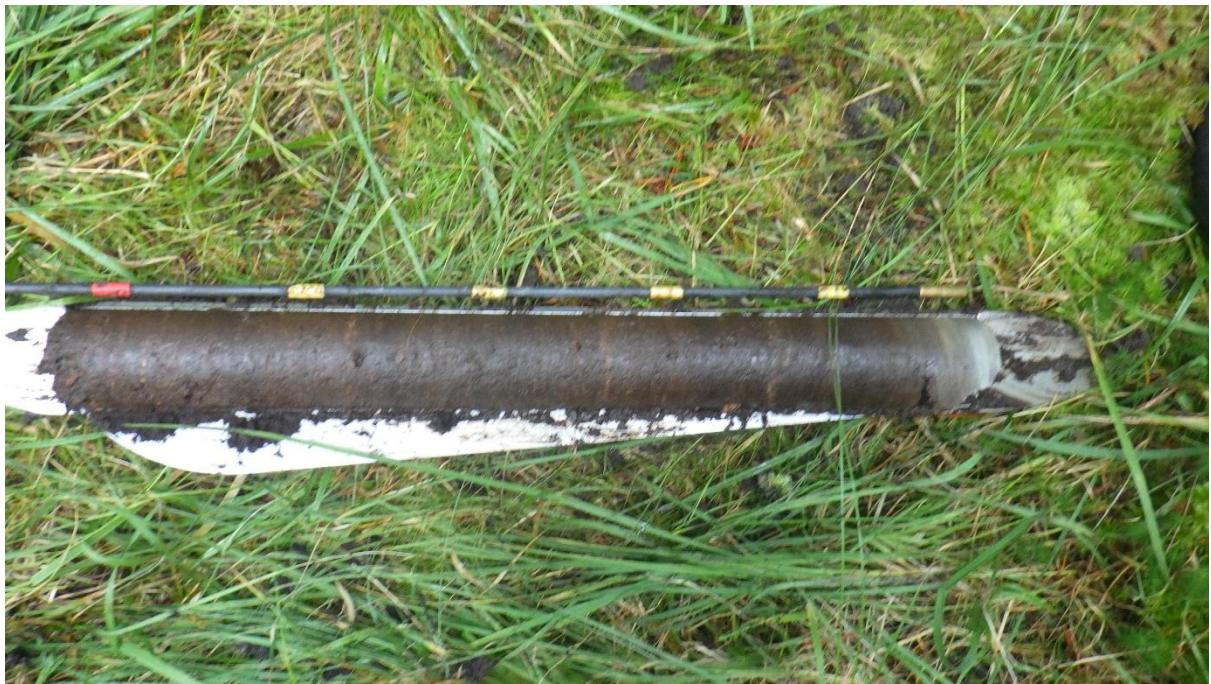
Notes: Highly decomposed peat overlying light grey at the base (right of photo)

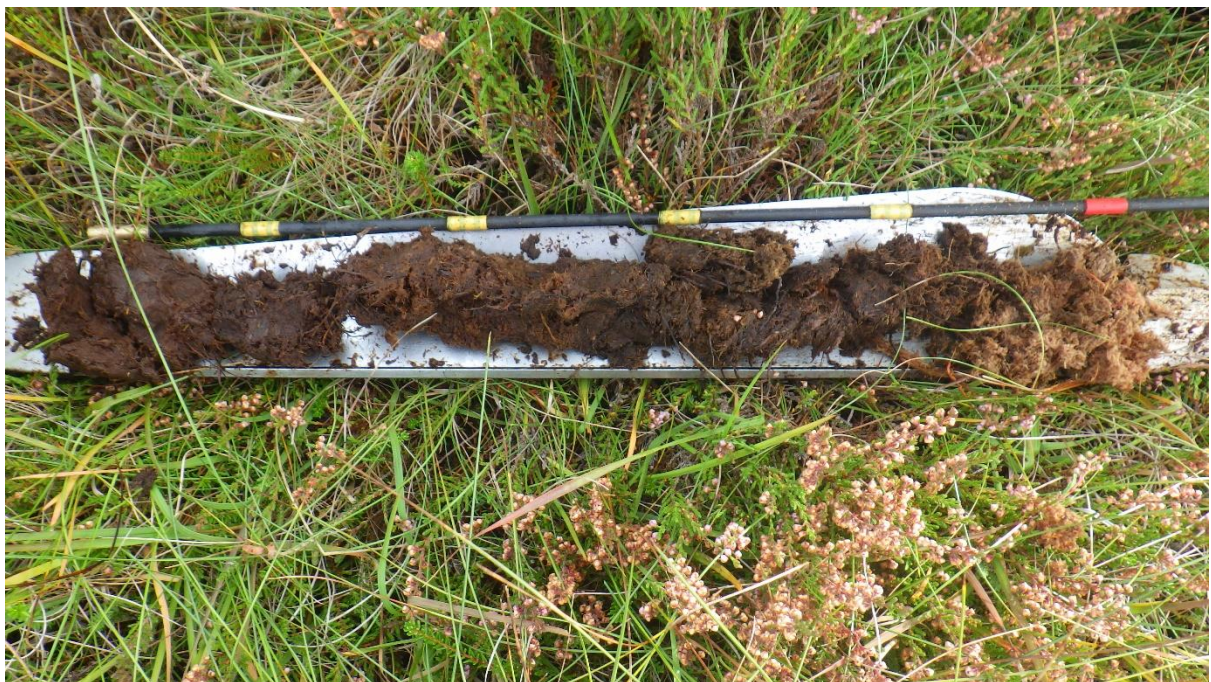
Notes: Highly fibrous, slightly decomposed peat. Surface layer visible to right of photo.

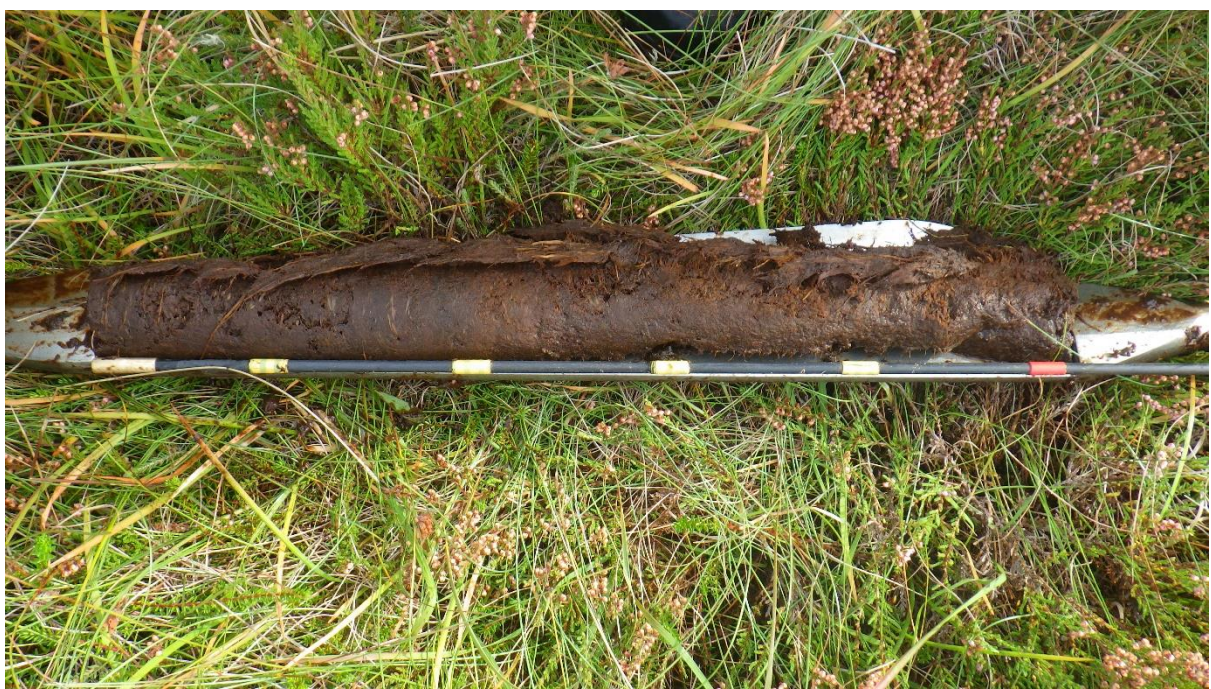
Notes: Moderately decomposed peat, fibrous with visible structure but containing significant amorphous material.

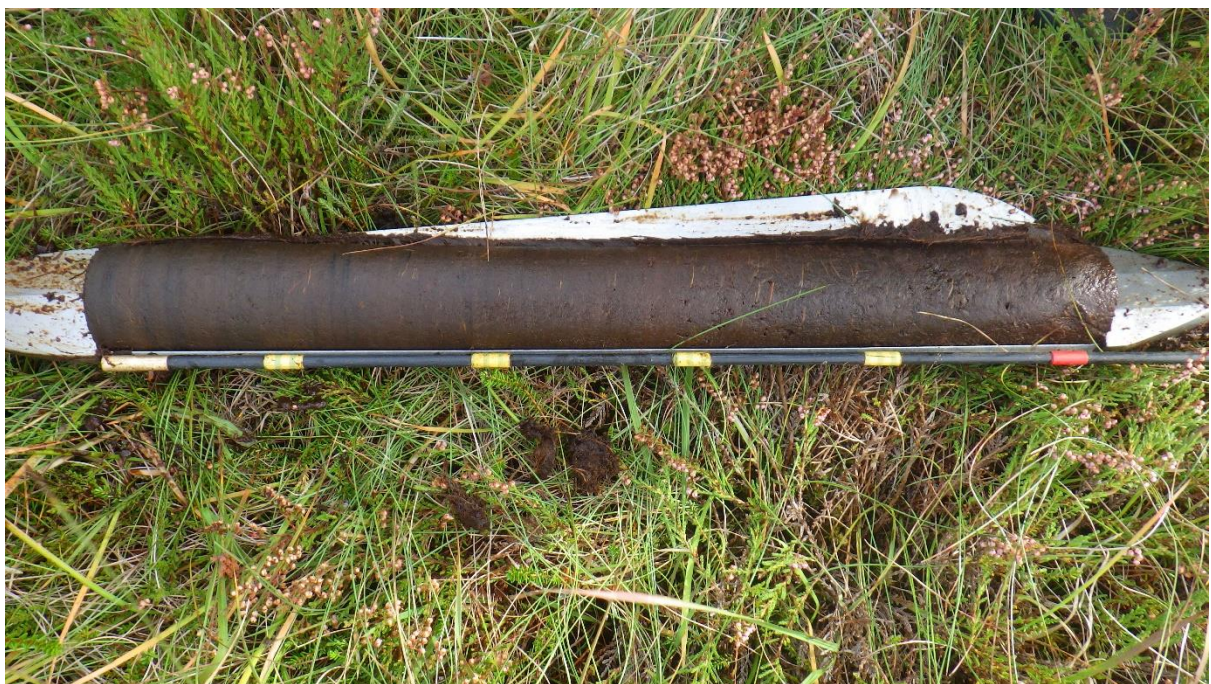
Notes: Highly decomposed peat, slightly wetter in top 10cm (right of photo).

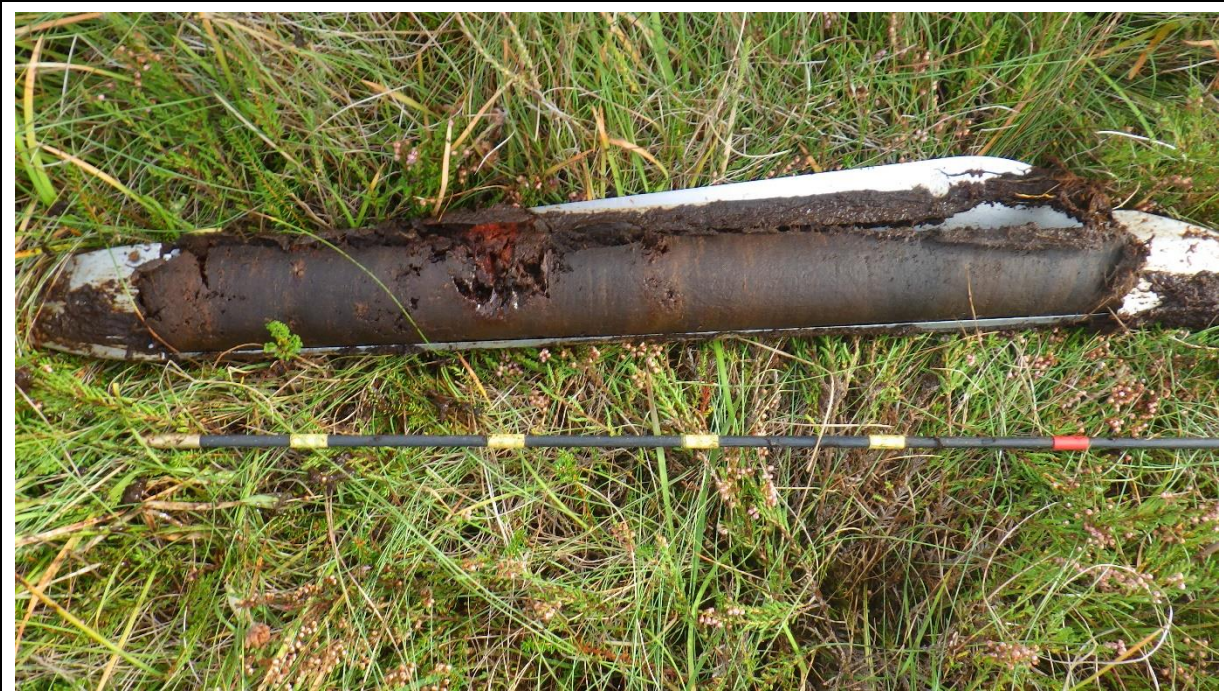
Notes: Large wood fragment present at approximately 1.8 m bgl.

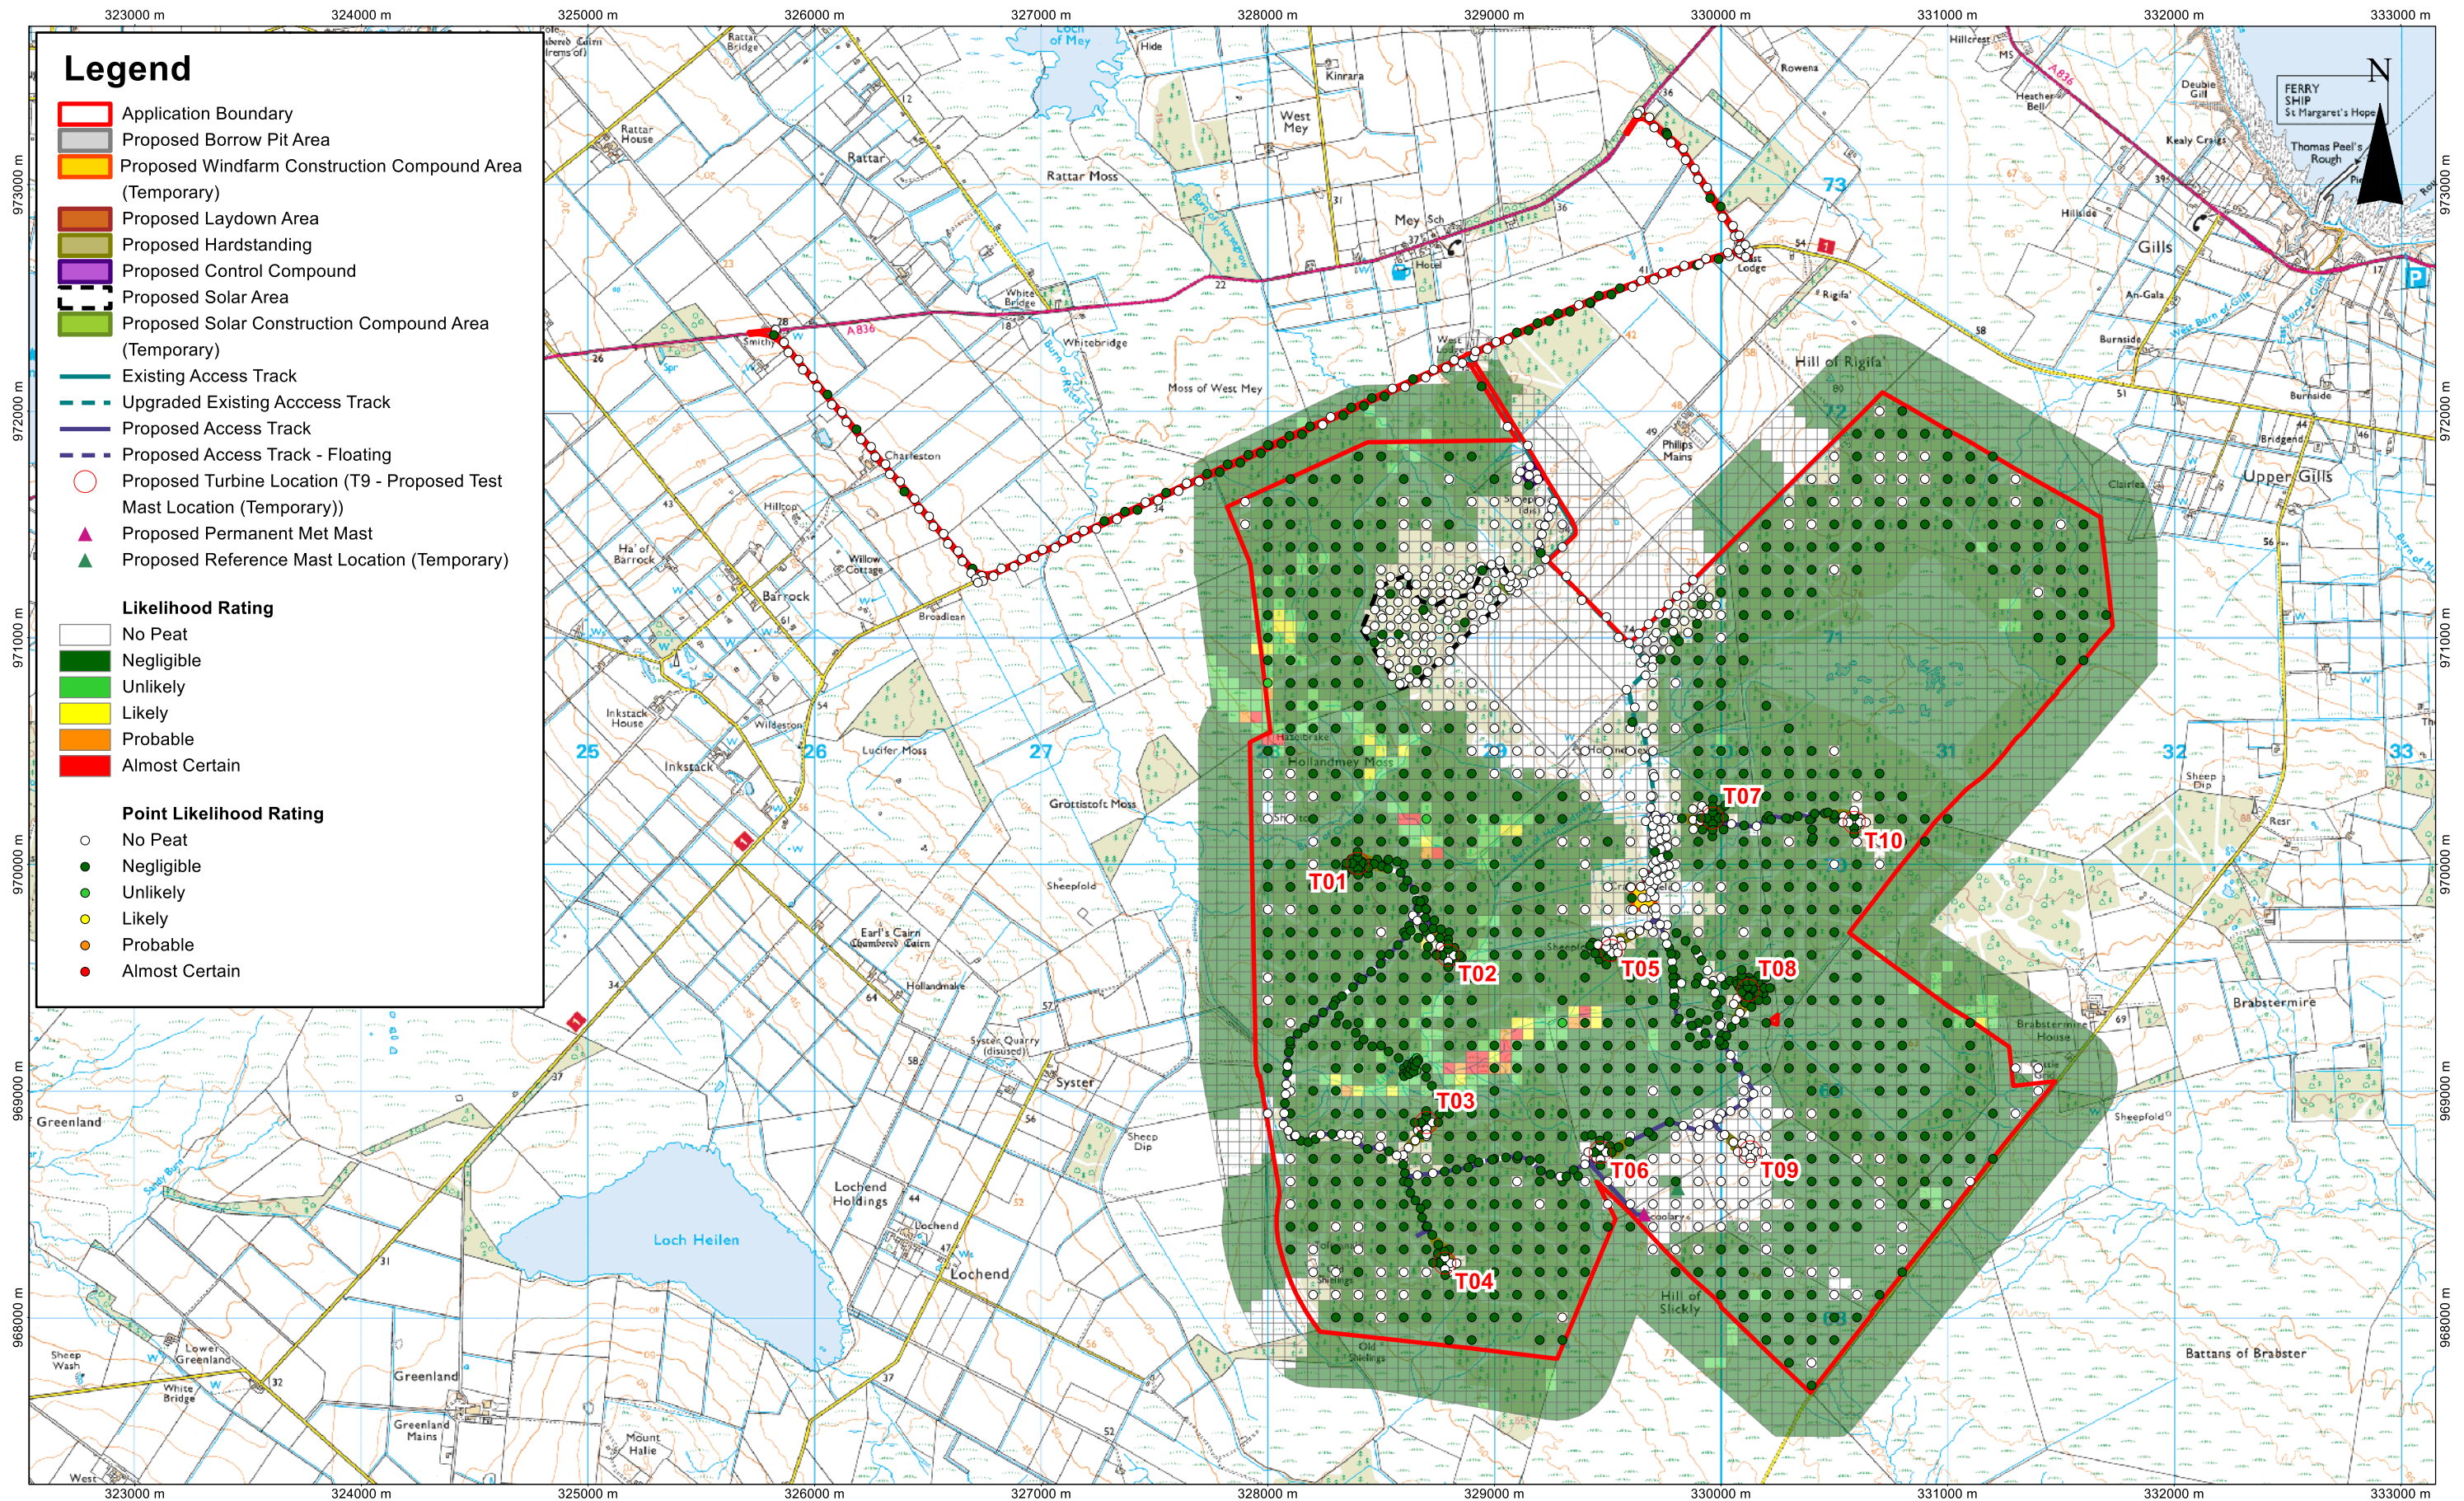
Drg No	HMY_Peat_CI	
Rev	E	Datum: OSGB36
Date	12/11/2021	Projection: TM
Figure	10.1.6p

**Hollandmey Renewable Energy Development**  
**Figure 10.1.6p: Peat Depth Mapping**  
**- SE**
