**HARESTANES WEST WINDFARM ENVIRONMENTAL
IMPACT ASSESSMENT**

TECHNICAL APPENDIX 8.6: BAT REPORT – TREE SURVEYS

Ae, Dumfries & Galloway

25.10.2024 VERSION 2

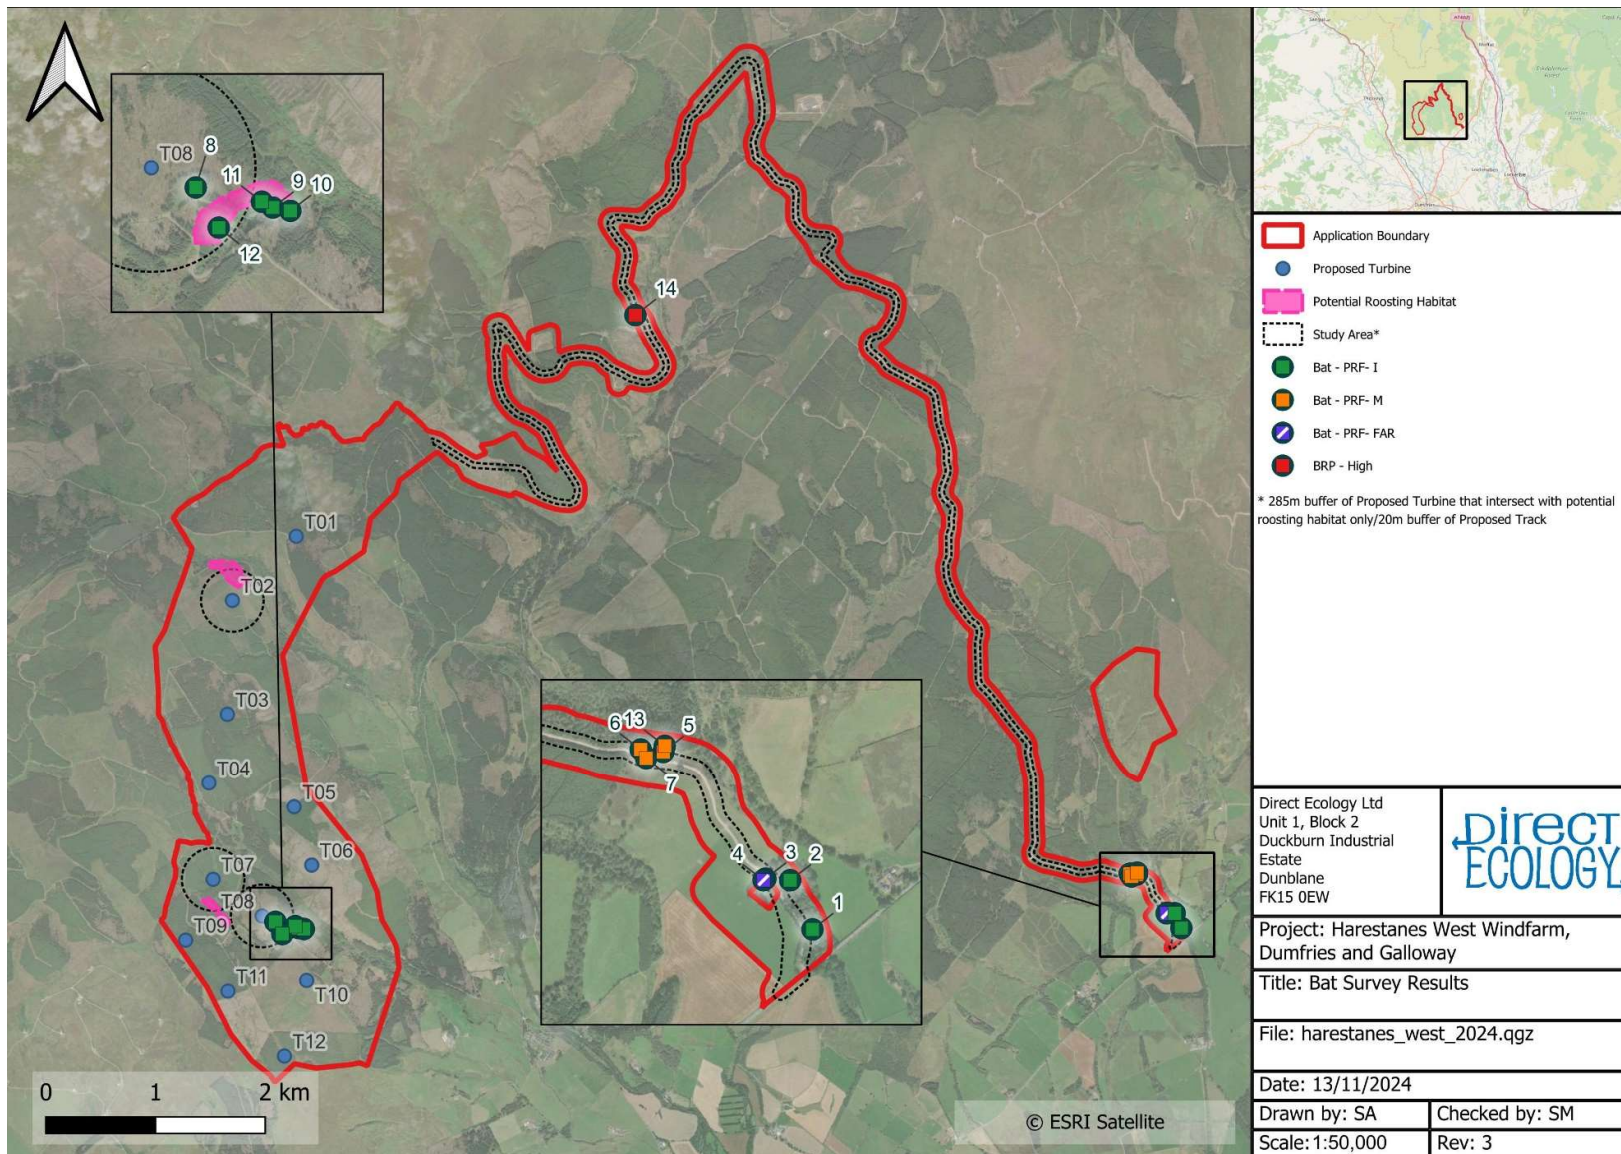
Figure 2: Bat survey results.

A bat box (TN 13) was noted at grid reference NY 03856 90708 and this contained a single bat dropping, likely pipistrelle species, so is confirmed as a bat roost. It is over 35 m from the track.

A building (TN 14) at NX 99282 95799 was externally surveyed for bat roost potential. The slate roof had a number of potential ingress points including lifted and missing slates, lifted flashing at the apex and gaps at the wallhead. The windows were all broken, so this also provided opportunities for bats to enter the ground level of the building. This building is deemed to have high suitability for roosting bats based only on an external survey. However, no evidence of use by bats, such as droppings or staining, was noted. No internal survey of the building was carried out as it is over 50 m from the proposed track route and therefore beyond the disturbance buffer for bats.
